# Building Condition Assessment & Capital Reserve Fund

## **Service Buildings in West Lorne Ontario 8662 Graham Road, West Lone, Ontario**

Prepared for:  
Ontario Clean Water Agency  
Suite 370 - 450 Sunset Drive  
St. Thomas, ON  
N5R 5V1

Date August 12, 2020  
IRC LB20-024CR-23145

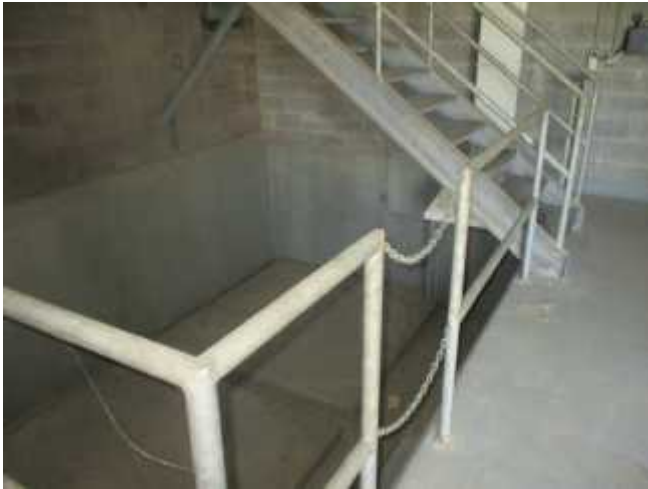
Concrete sub structural components were noted in fair to good condition.

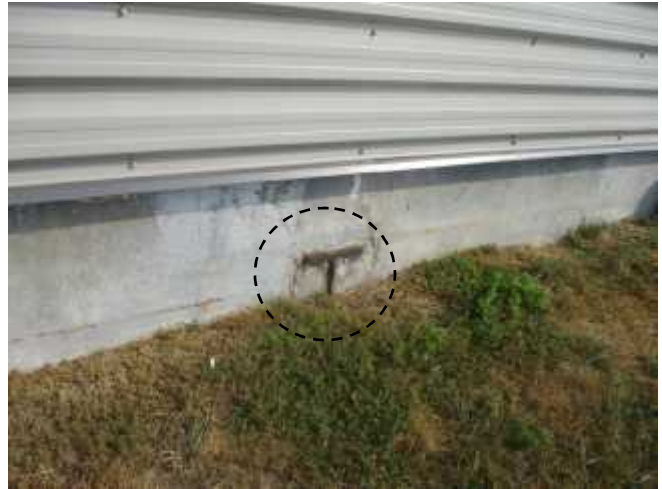
Exposed corroded steel was noted imbedded at the foundation wall of Building A. Epoxy coating may be considered.

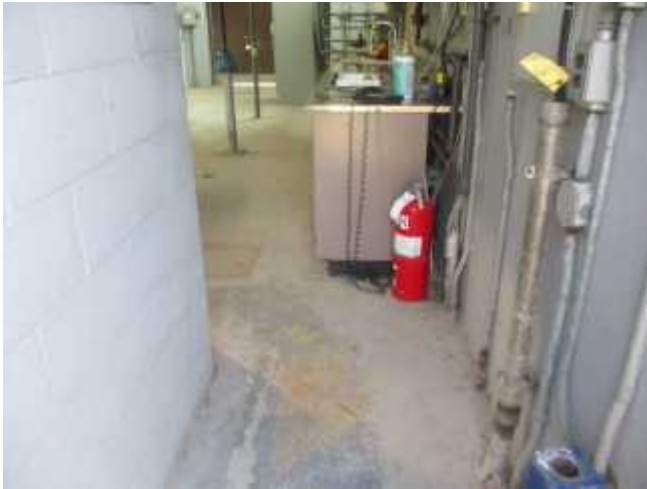
General view of the slab-on-grade floor of building B.

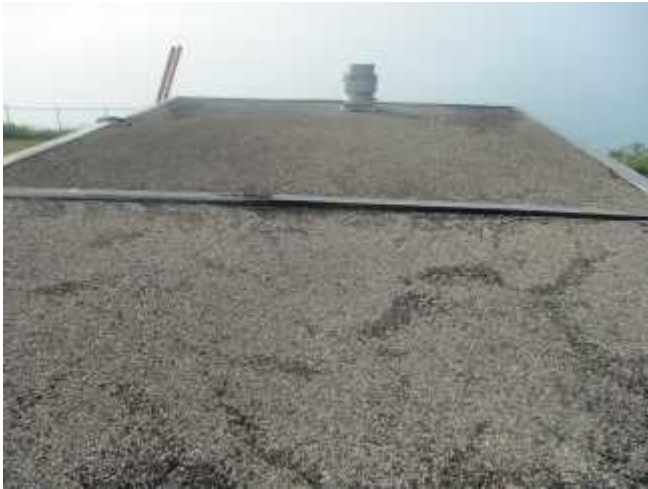
General view of the BUR system atop Building A.

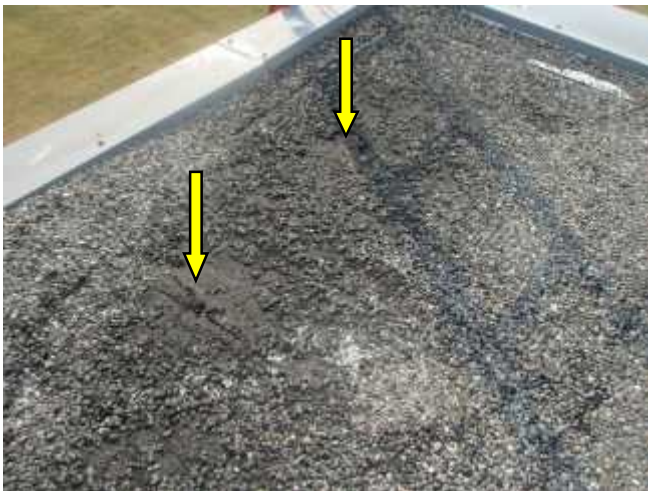
Exposed deteriorated membrane was noted on the southwest corner of the roof.

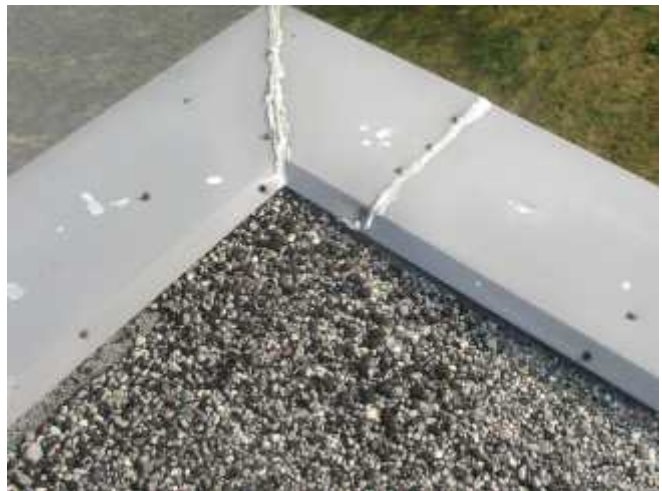
Hardened and deteriorated sealants were noted on the joints of parapet flashing.

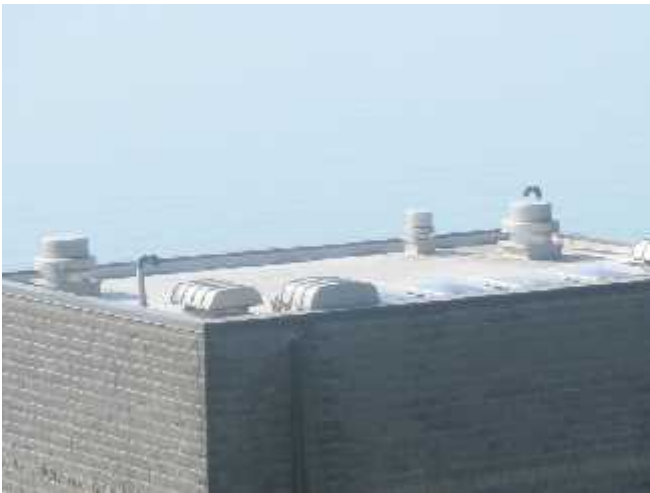
General view of the PVC membrane atop Building B.

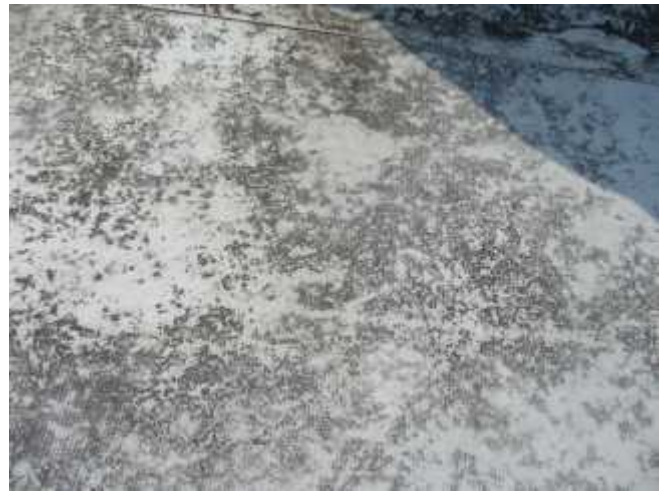
Deteriorated surface of the PVC membrane.

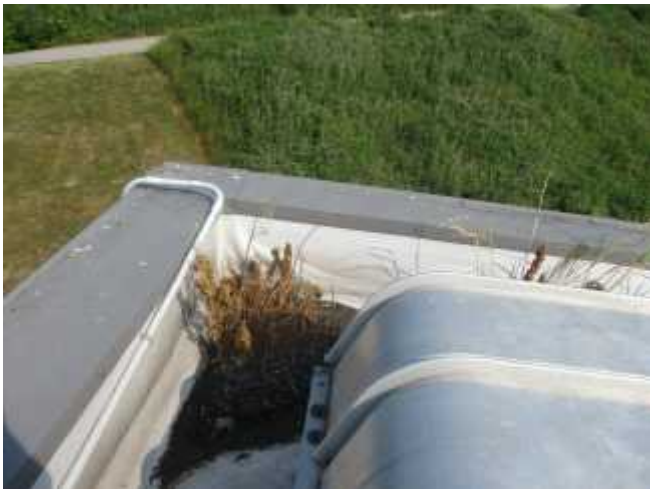
Debris accumulation and growth on the roof.

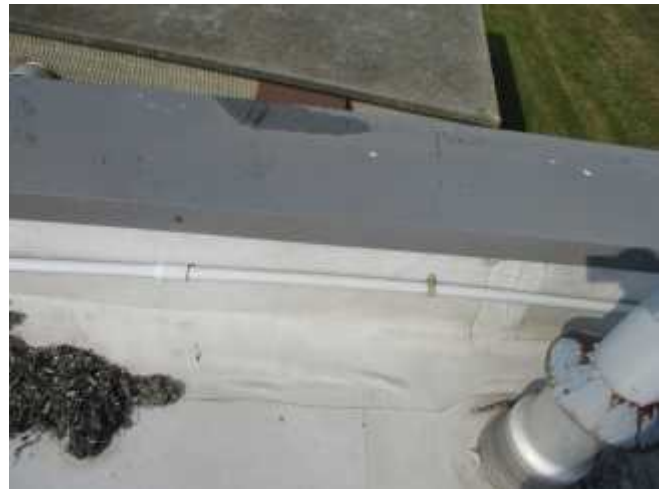
Wrinkled and tented membrane noted along the roof edge.

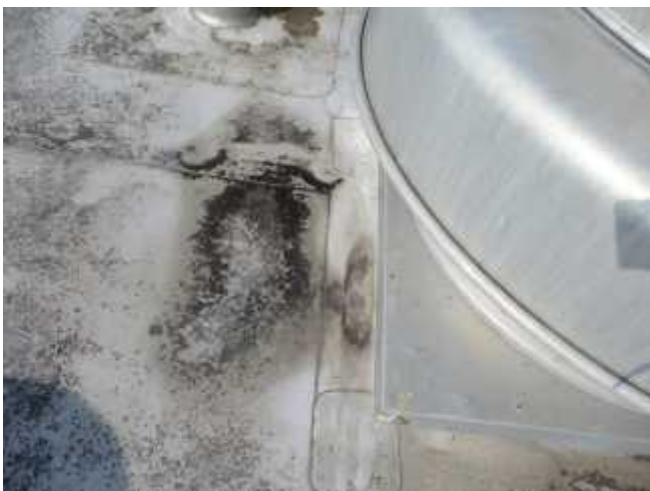
Ponding water and deteriorated membrane atop the roof.

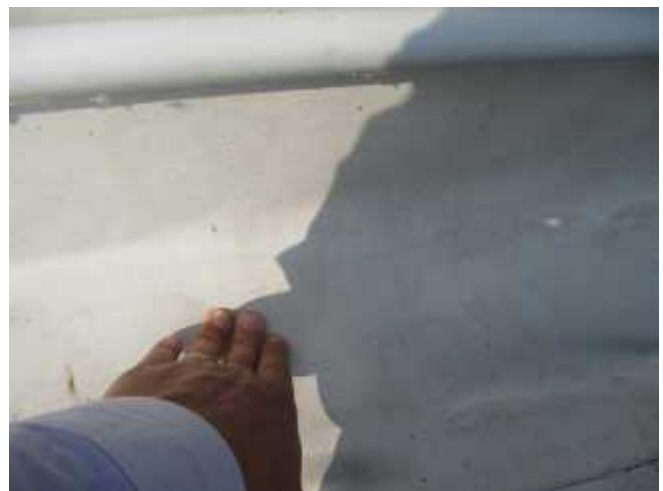
Tenting was noted to be severe along the west edge.

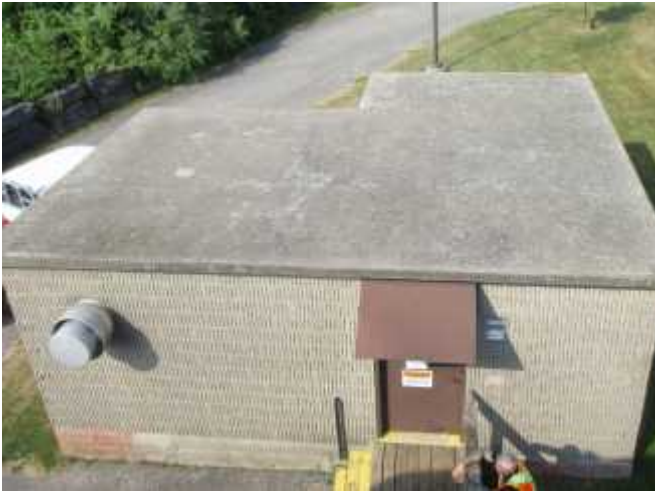
General view of exposed concrete decking atop Building C.

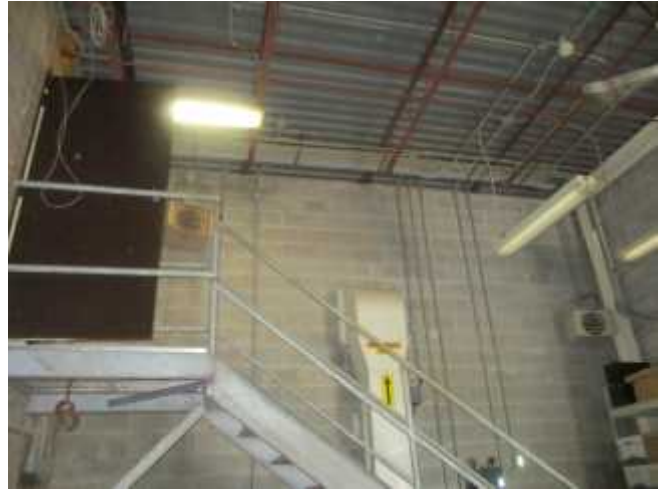
The east and south walls appeared in better condition than the west wall.

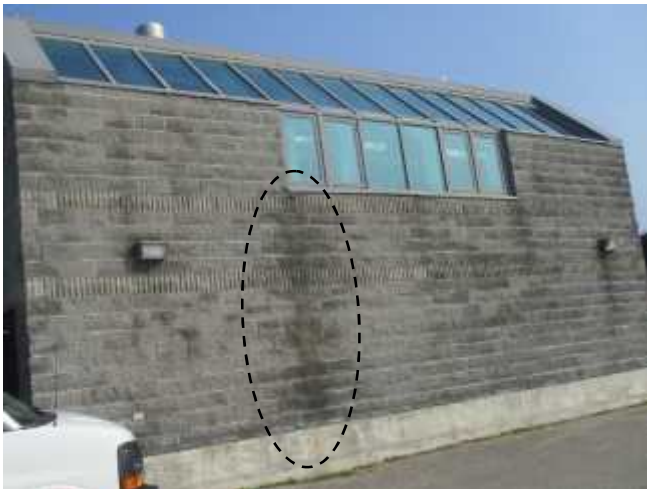
Moisture stained walls on the south elevation of Building B.

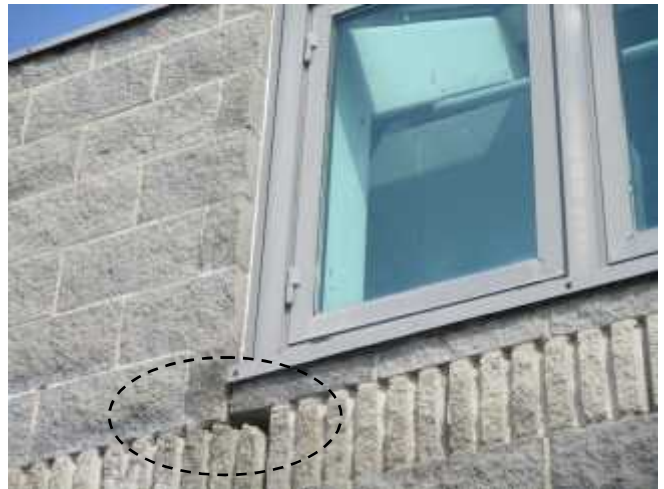
Missing mortar was noted below corner of the window.

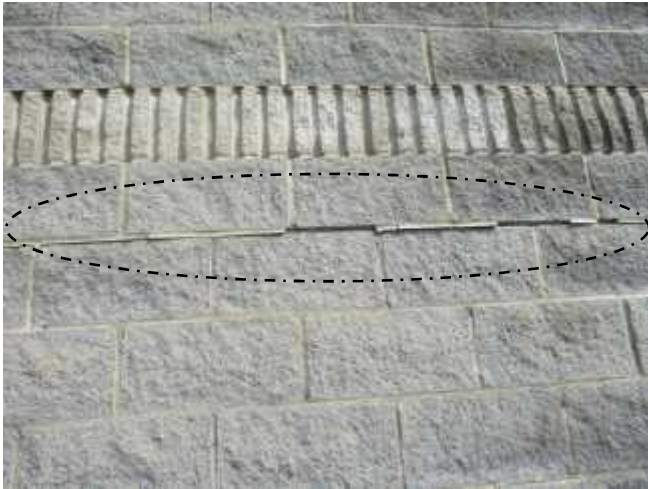
Areas of damaged mortar joints were noted on all elevations of Building B.

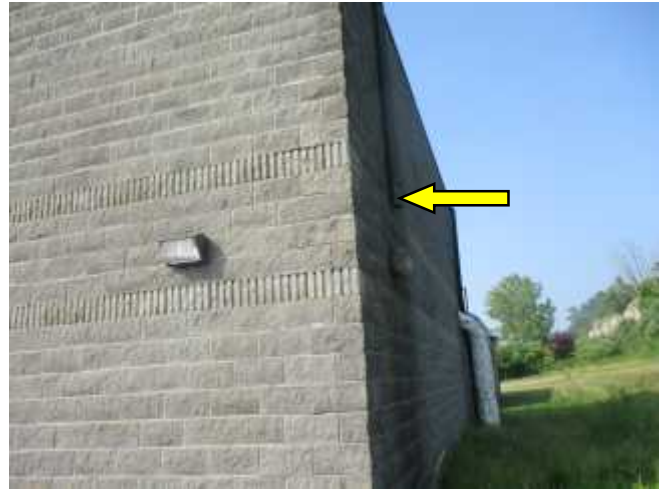
Missing piece of a downpipe on the north elevation of Building B.

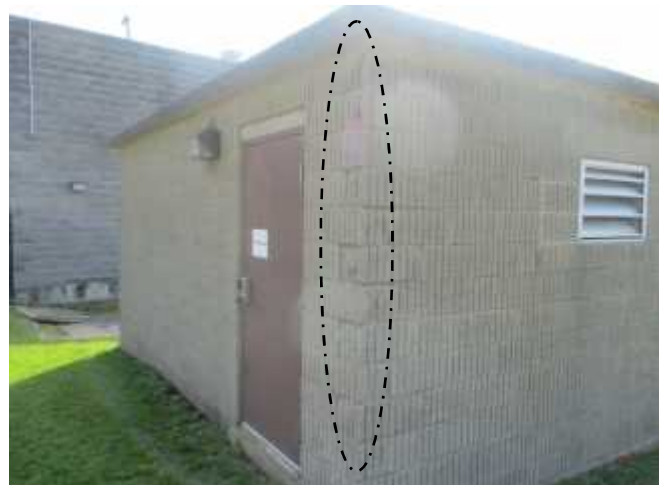
Spalled concrete blocks on the northwest corner of Building C.

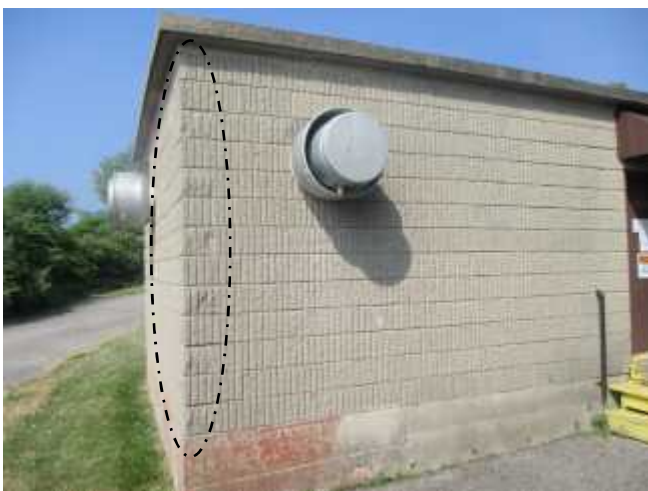
Spalled concrete blocks on the southeast corner of Building C.

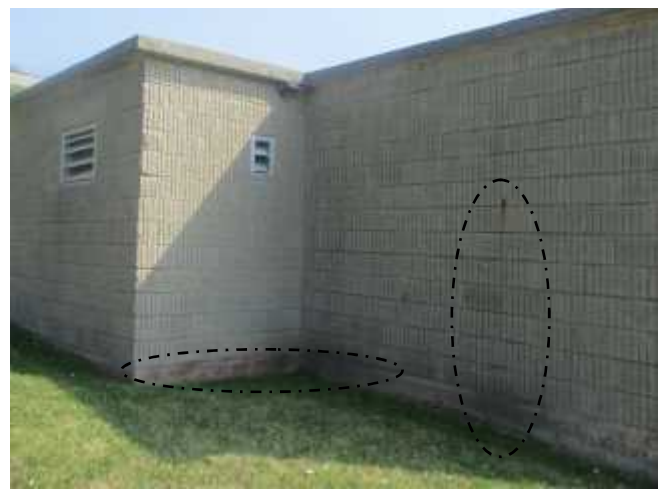
Moisture staining and damaged on the north elevation of Building C.

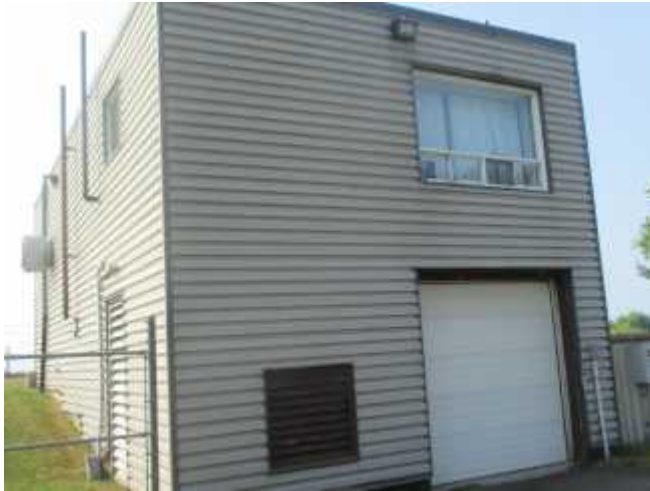
View of prefinished metal siding on north (right) and west (left) elevations of Building A.

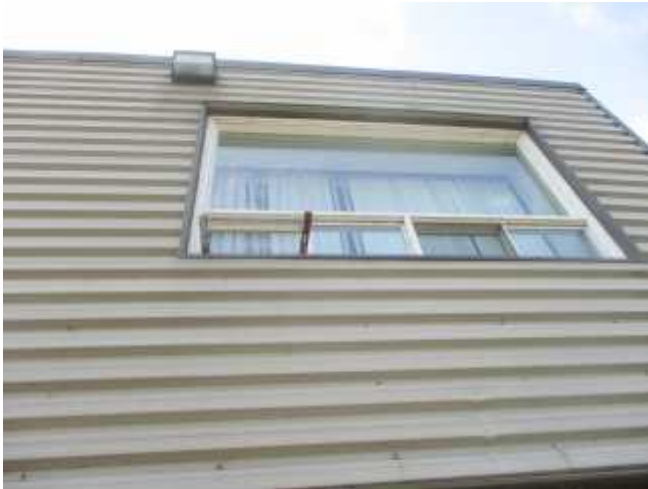
Exterior view of the window on the north elevation of Building A.

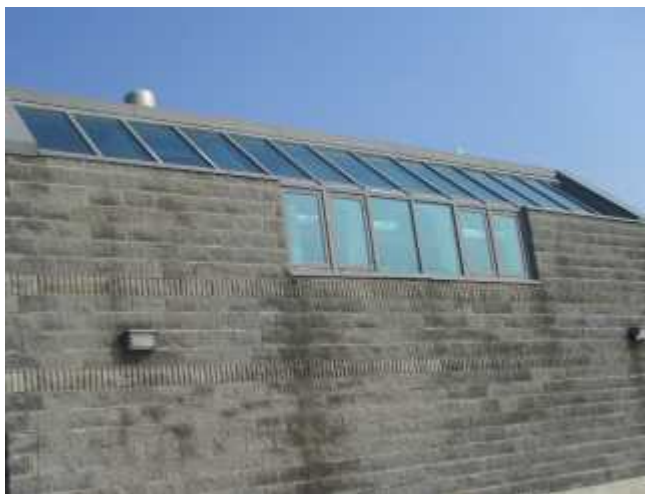
View of windows on the south elevation of Building B.

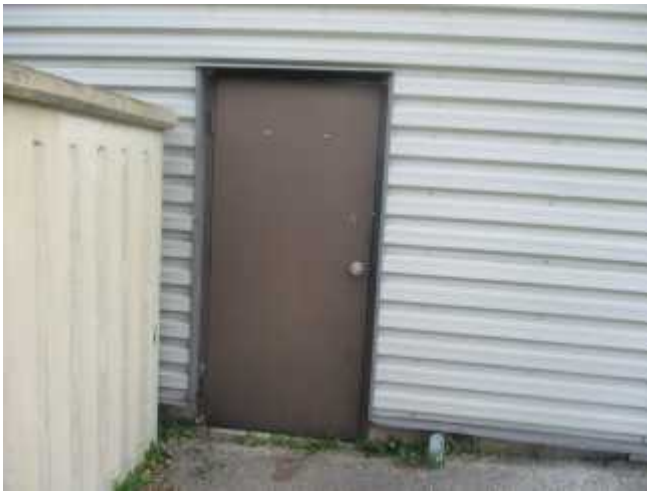
View of the secondary entrance door to Building A.

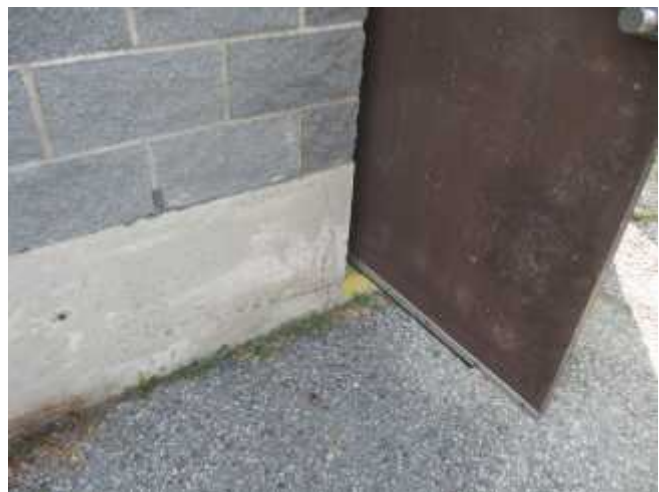
Fading and deteriorated finish on entrance of Building B.

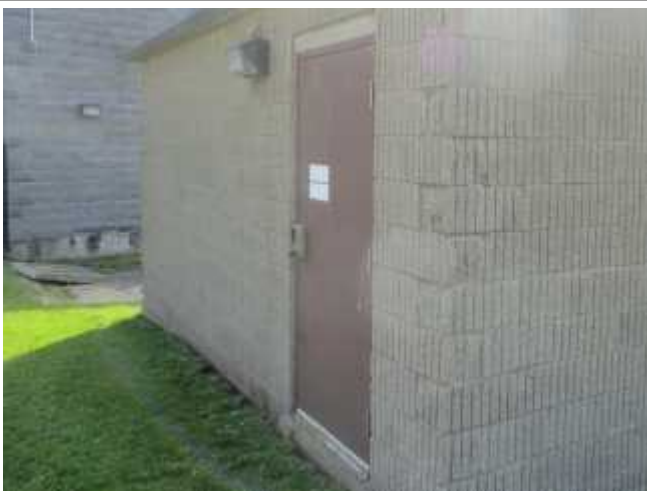
Secondary entrance door to the basement of Building C was noted to be difficult to operate.

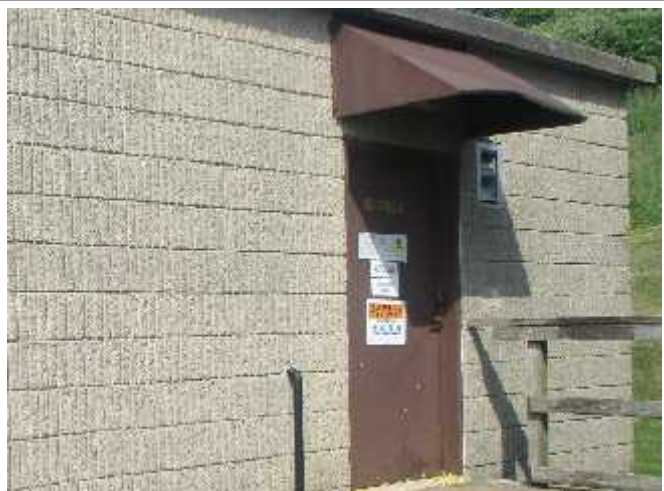
Corrosion was noted on the main entrance door and door hardware of Building C.

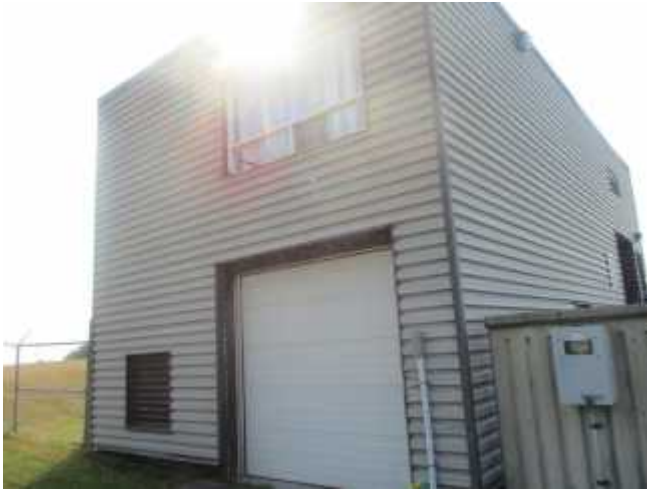
Prefinished metal roll-up door on the north elevation of Building A.

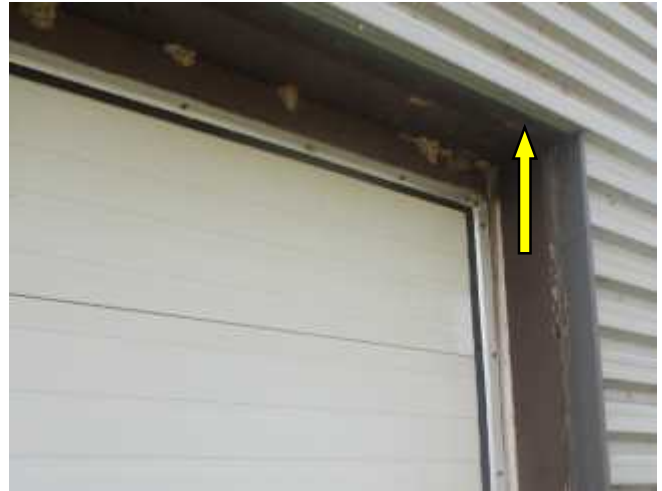
Deteriorated sealants at perimeter of a garage door of Building A.

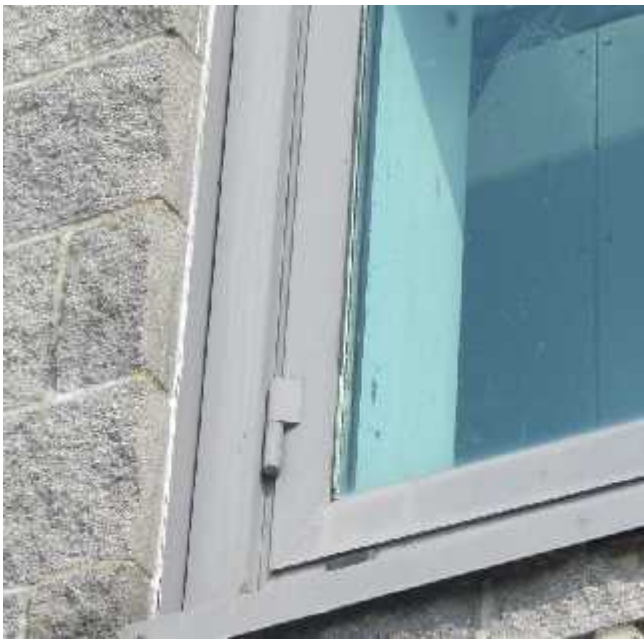
Split sealants around the windows of Building B.

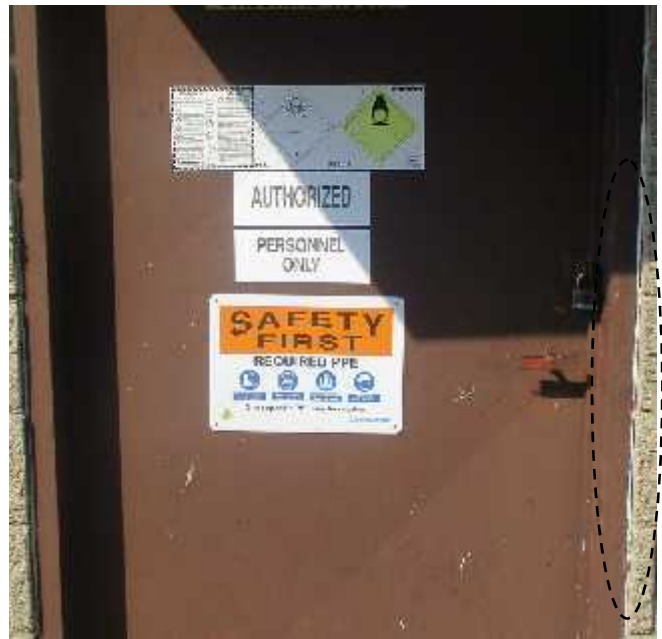
Deteriorated sealants at the door perimeter of Building C.

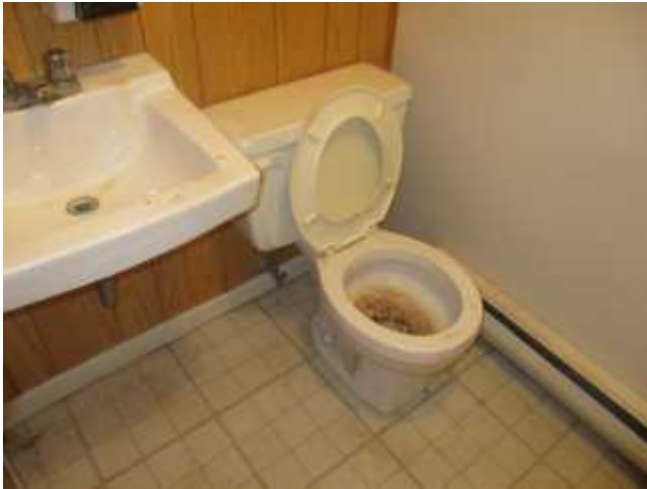
The bathroom fixtures and finishes appeared in poor condition.

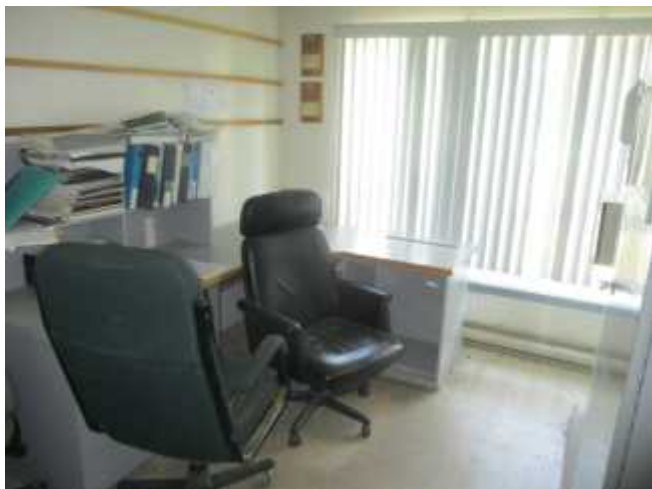
General view of interior finishes within the second floor of Building A.

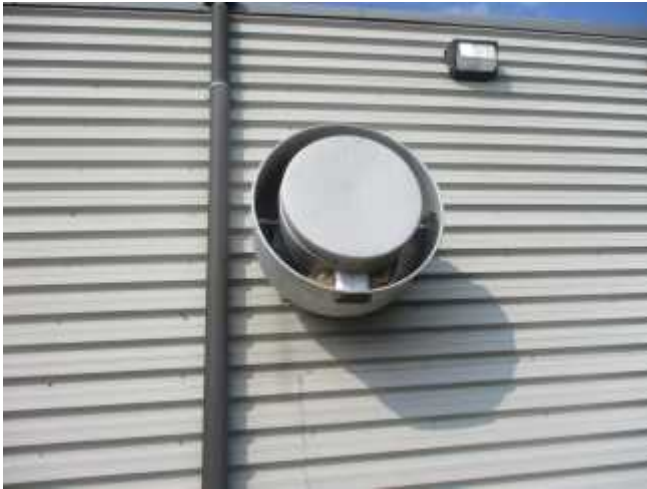
Hooded ventilation fan on the east elevation of Building A.

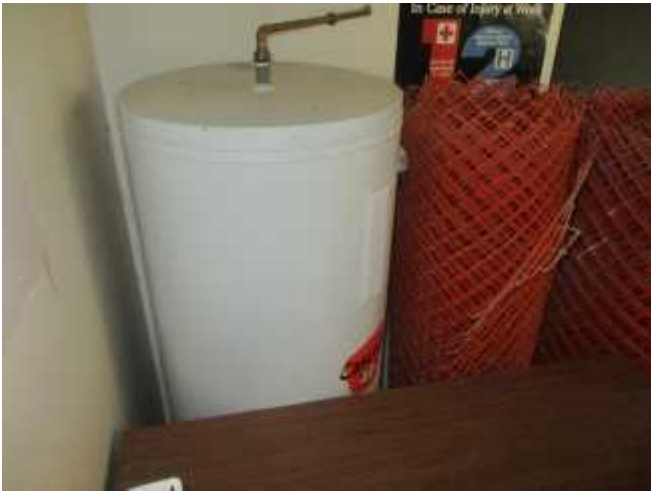
| Photographs |
|---|
| <p align="center">DHW heater on the second floor of Building A.</p> |

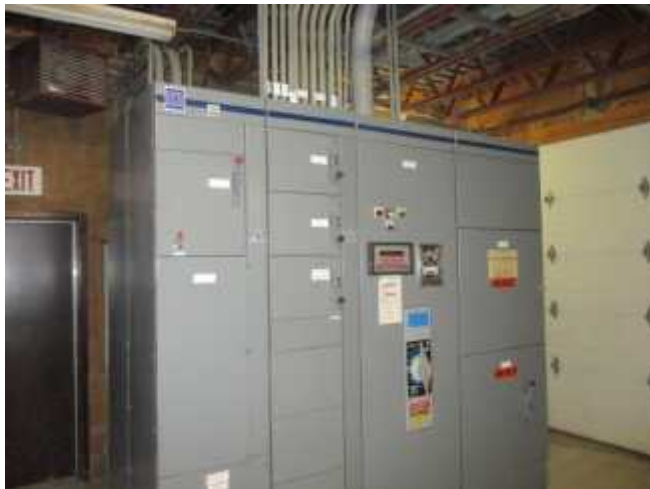
Main electrical distribution and disconnect switch serving all buildings.

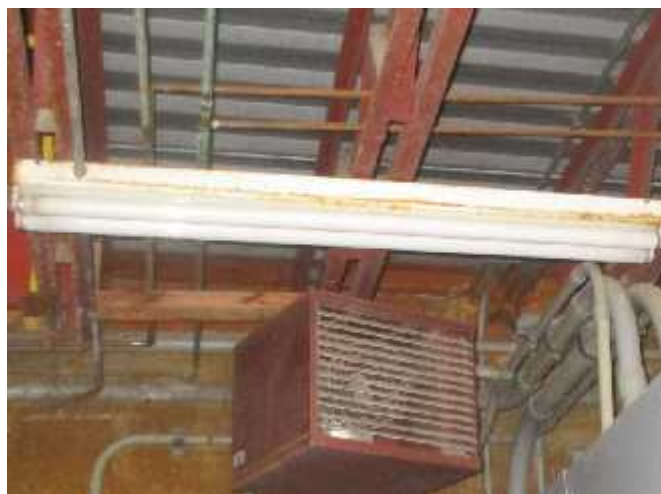
Light fixtures suspended at the ceiling.

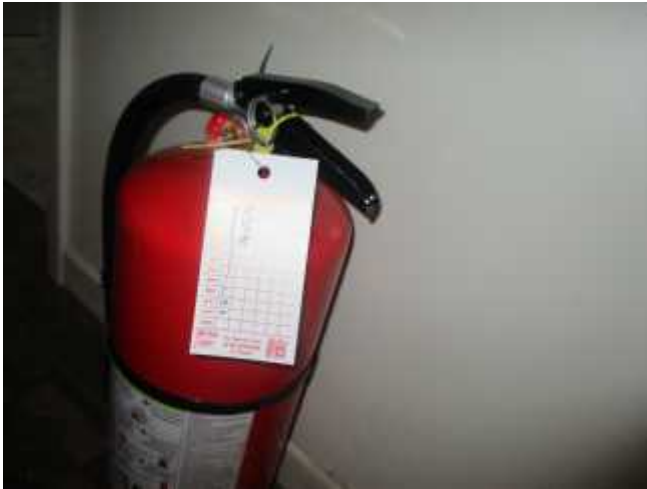
Typical portable fire extinguisher in Building A.

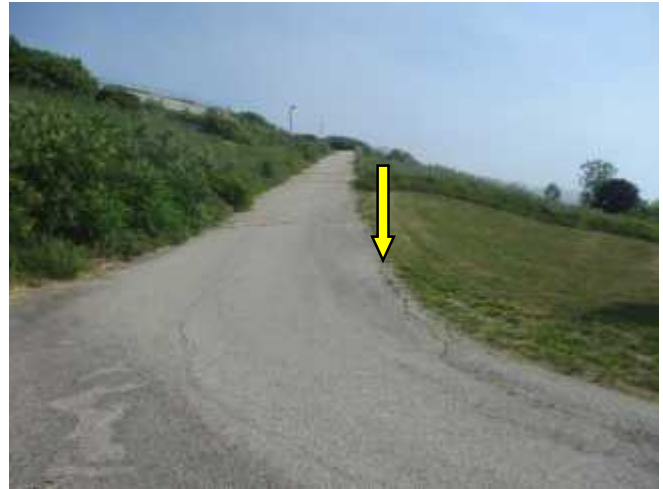
General view of asphalt pavement roadway at the central portion of the site. Areas of longitudinal cracks noted.

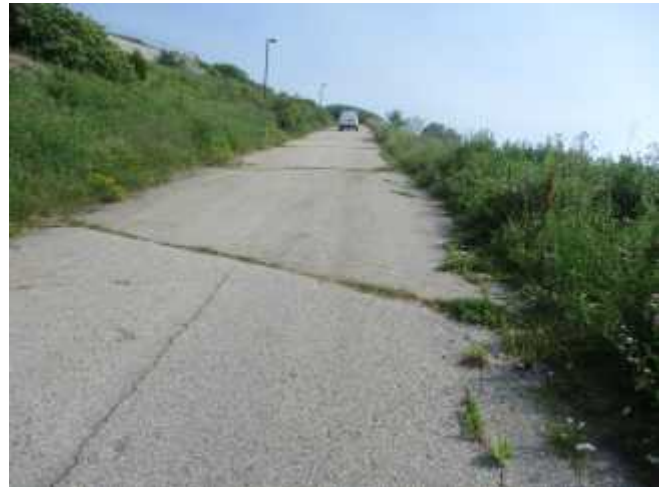
Cracking and growth within the cracks of the asphalt pavement.

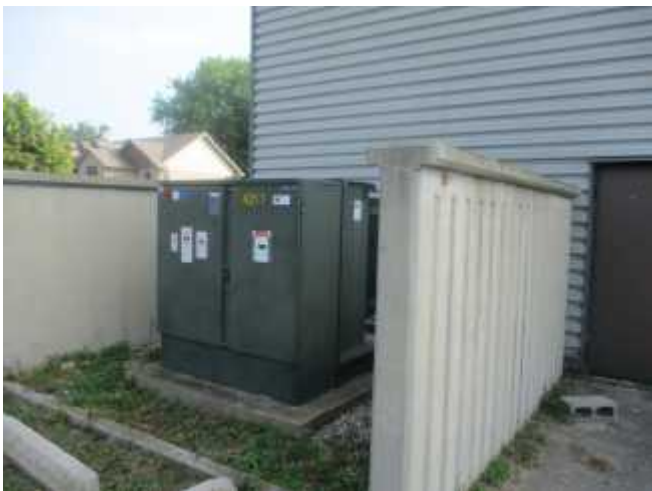
| Photographs | |
|---|---|
| <p>Concrete screen walls near the transformer were noted to be in good condition.</p> | <p>Concrete pad at the entrance to Building B.</p> |

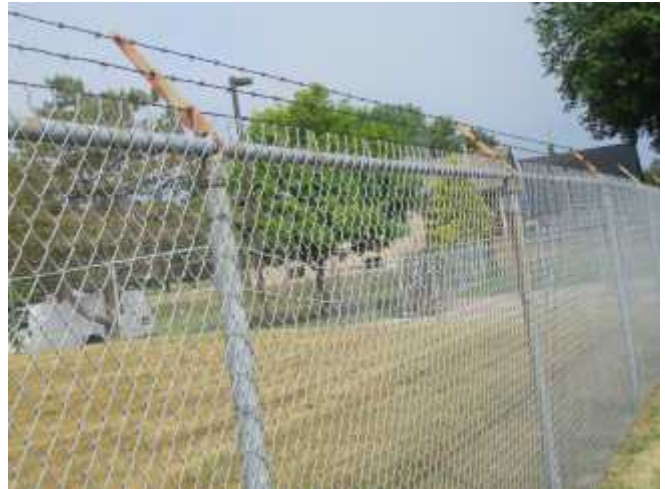
Areas of corrosion noted on the posts.

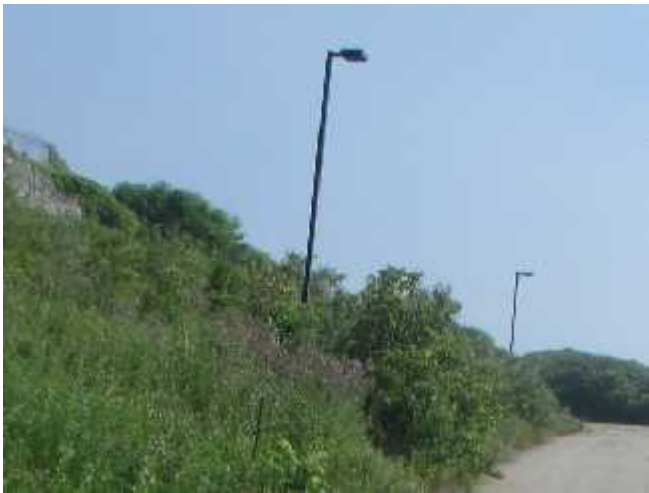
| Photographs | |
|---|---|
| <p>Exterior light posts on the central portion of the site.</p> | <p>Concrete base of the light posts were noted in good condition.</p> |

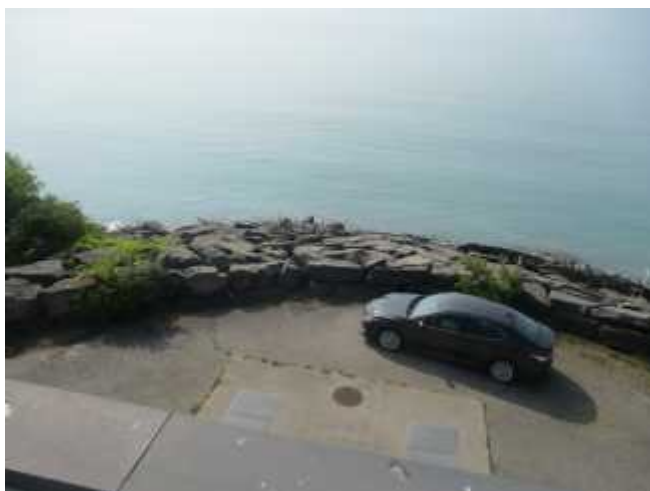
General view of the south retaining wall.

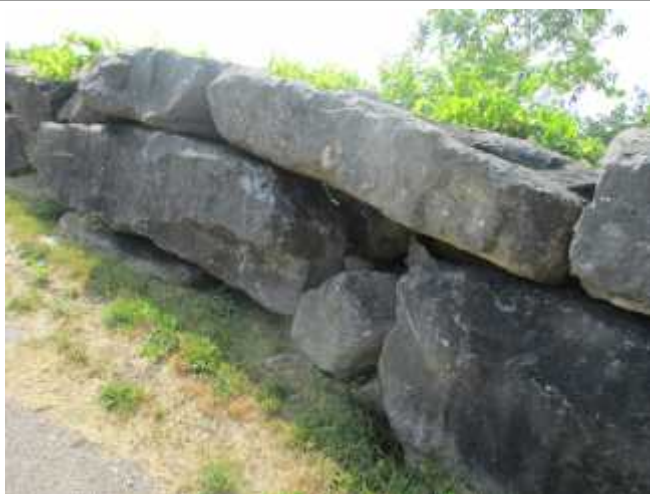
Evidence of minor erosion and shifted units observed at the south wall.

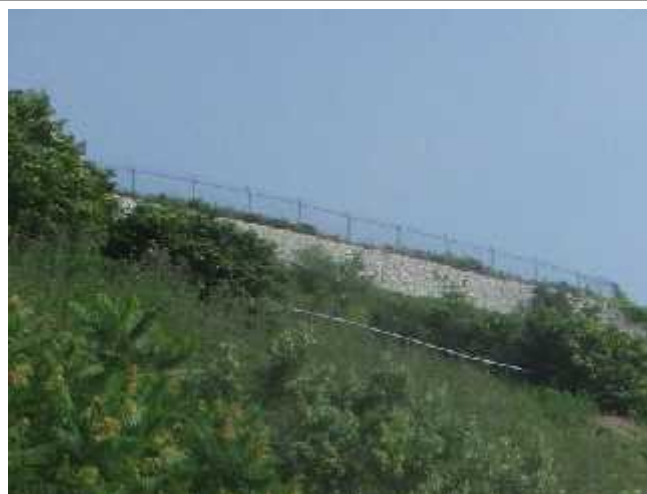
General view of the Gabion style retaining wall in the middle portion of the site.

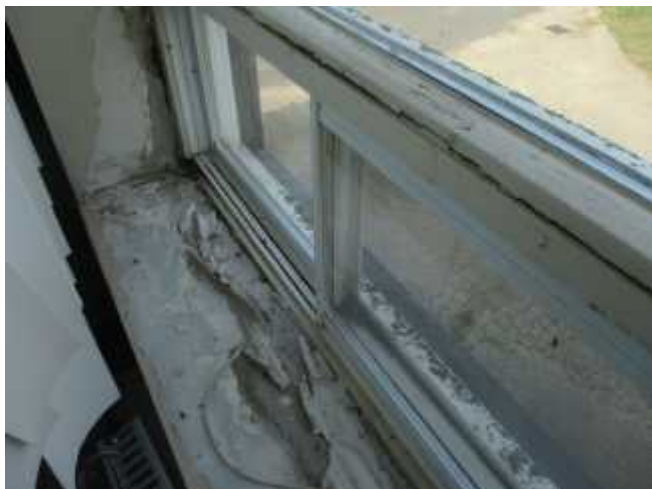
Damaged window sill of Building A where mould growth is suspected.
