**West Lorne Welded Steel Standpipe  
Remotely Operated Vehicle Inspection and Report  
November 4, 2020**

**Remotely Operated Vehicle Inspection and Report (ROV) – West Lorne Standpipe (SP)**

## WELDED STEEL STANDPIPE INSPECTION REPORT

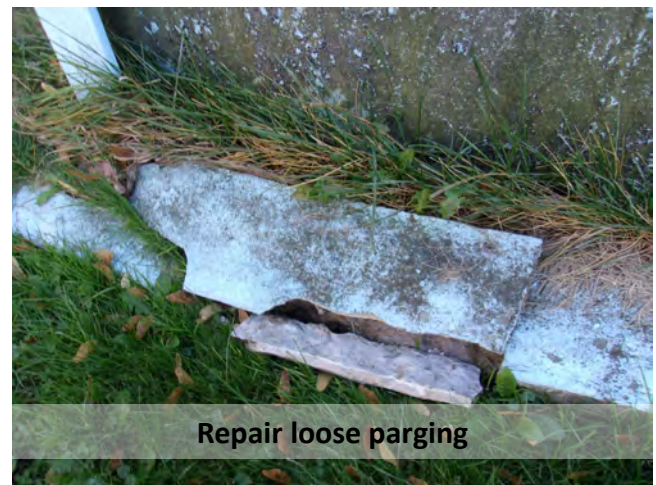
40

Repair loose parging

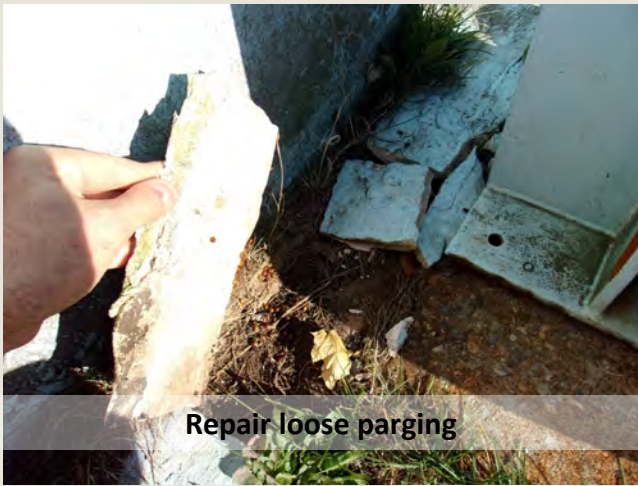
49

Repair loose parging

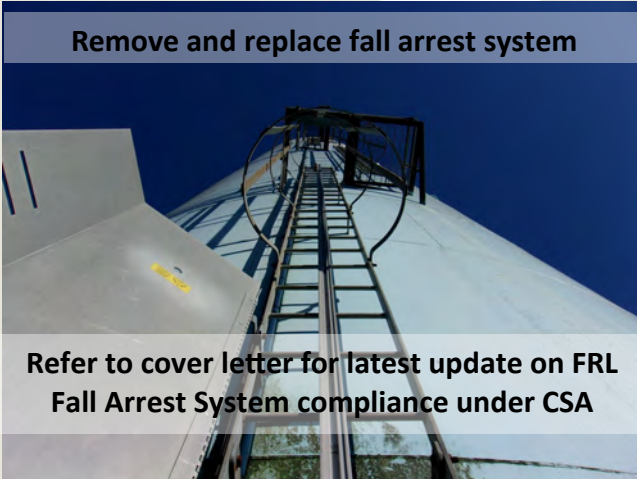
67

Remove and replace fall arrest system

Refer to cover letter for latest update on FRL Fall Arrest System compliance under CSA

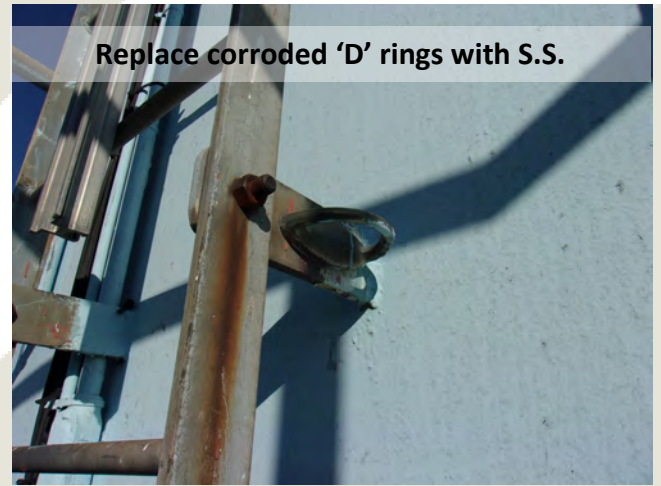
74

Replace corroded 'D' rings with S.S.

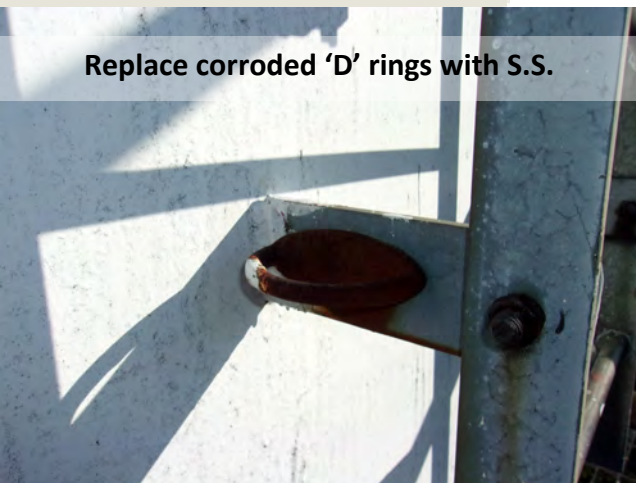
79

Replace corroded 'D' rings with S.S.

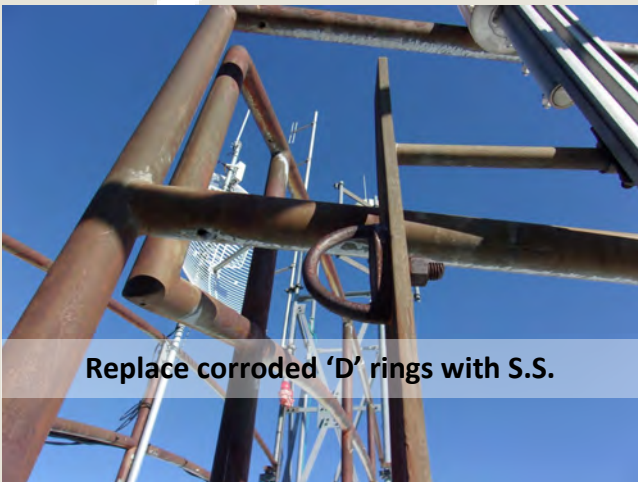
85

Replace corroded 'D' rings with S.S.

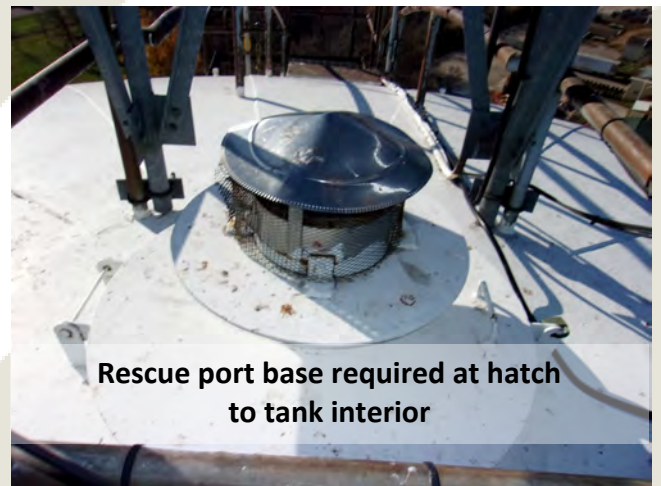
106

Rescue port base required at hatch  
to tank interior

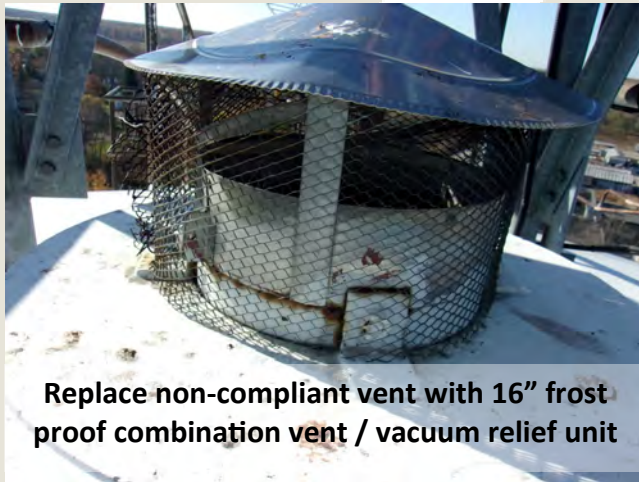
107

Replace non-compliant vent with 16" frost  
proof combination vent / vacuum relief unit

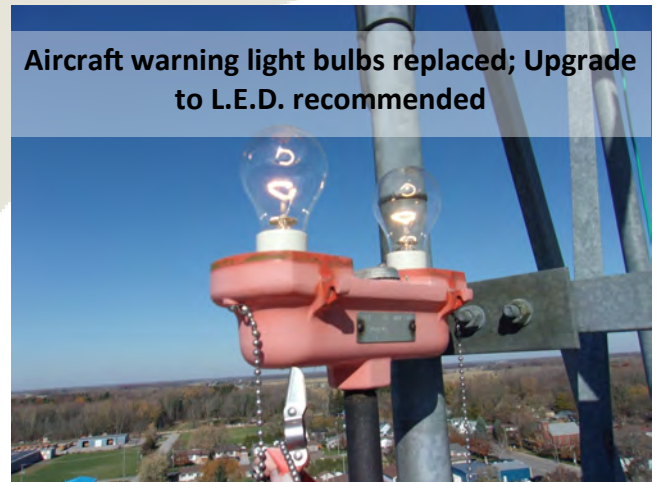
110

Aircraft warning light bulbs replaced; Upgrade  
to L.E.D. recommended

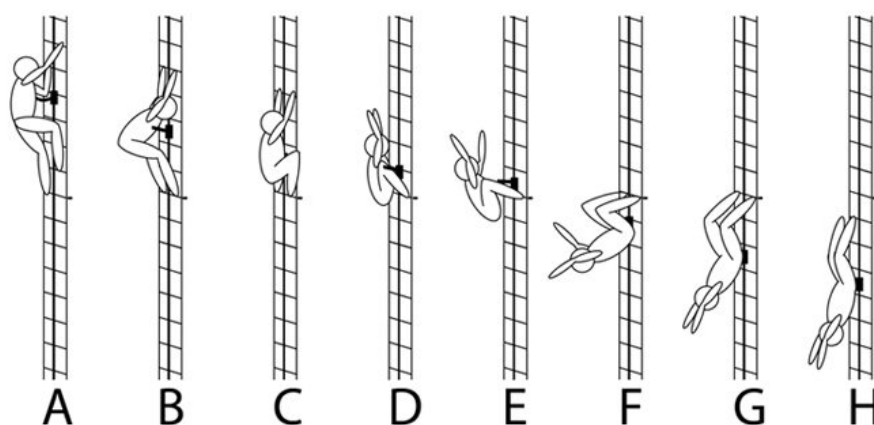
Figure 1: How the water tower worker fell

- A. The worker is descending properly using the fall protection system.
- B. The worker bends at the waist.
- C. The worker's legs fold into a squat position while the worker's hands catch the next rung. The squat position allows the trolley to travel below the height of the worker's knees.
