**West Lorne Welded Steel Standpipe  
Remotely Operated Vehicle Inspection and Report  
November 4, 2020**

**Remotely Operated Vehicle Inspection and Report (ROV) – West Lorne Standpipe (SP)**

## WELDED STEEL STANDPIPE INSPECTION REPORT

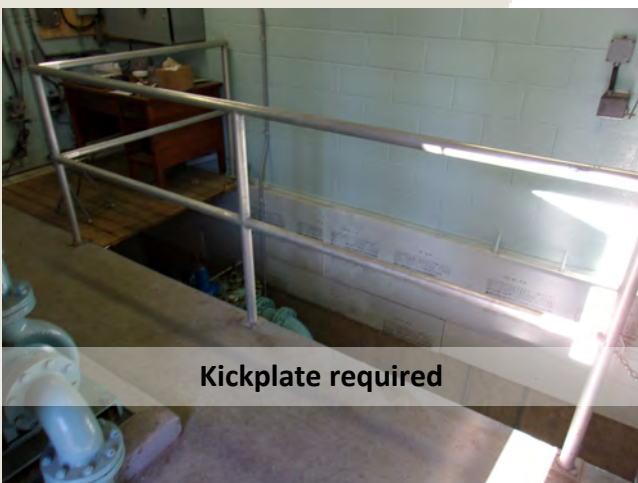
23

Kickplate required

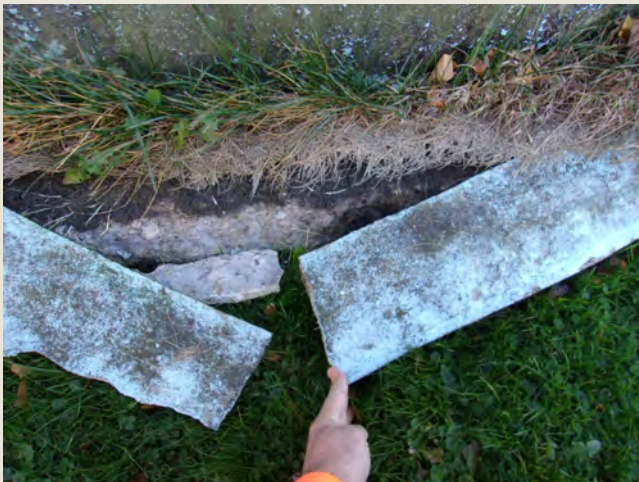
40

ANCHORAGE			Photo No.
ARE BASE PLATES DETERIORATED OR IN POOR CONDITION?	N/A		--
ARE ANCHOR BOLTS & NUTS DETERIORATED OR IN POOR CONDITION?	N/A		--
ARE ANCHOR BOLT CHAIRS DETERIORATED OR IN POOR CONDITION?	N/A		--
ARE ANCHOR BOLTS TIGHT?	N/A		--
CONDITION OF STRAP ANCHORS?	Good		37-48
<b>REPAIRS OR MAINTENANCE REQUIRED</b>

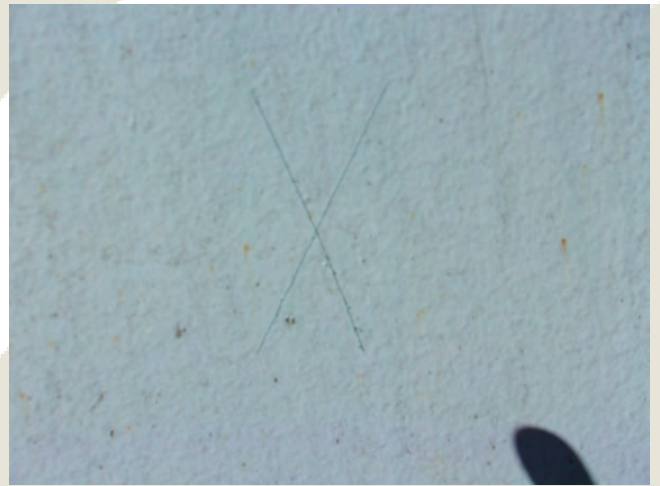
57

SUPPORT STRUCTURE			Photo No.
SKETCH PLATE CONDITION (TANK FLOOR)	N/I - covered in sediment		148-151
IS CYLINDER STRAIGHT?	Yes		57-62
ROOF CONDITION	Good		94-101
<b>REPAIRS OR MAINTENANCE REQUIRED</b>

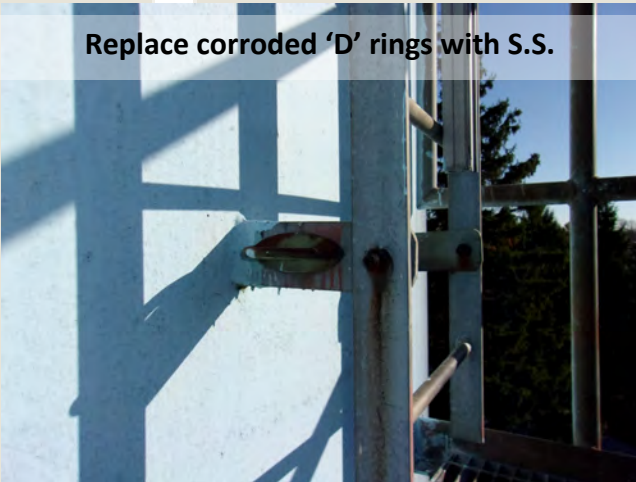
67

FALL ARREST SYSTEM			
LADDER LOCATION	SYSTEM TYPE	COMMENTS	
* To Valve Pit	None	Less than 9ft	25, 27
* To Roof	Aluminum TS Rail	Remove and replace fall arrest system	65-84

Remove and replace fall arrest system on vertical ladder

Remove and replace fall arrest system
