Ontario Clean Water Agency
Agence Ontarienne Des Eaux

Tri County Drinking Water System
Operations Report
Second Quarter 2024

Ontario Clean Water Agency, Southwest Region
Sam Smith, Sr. Operations Manager
Date: September 24, 2024

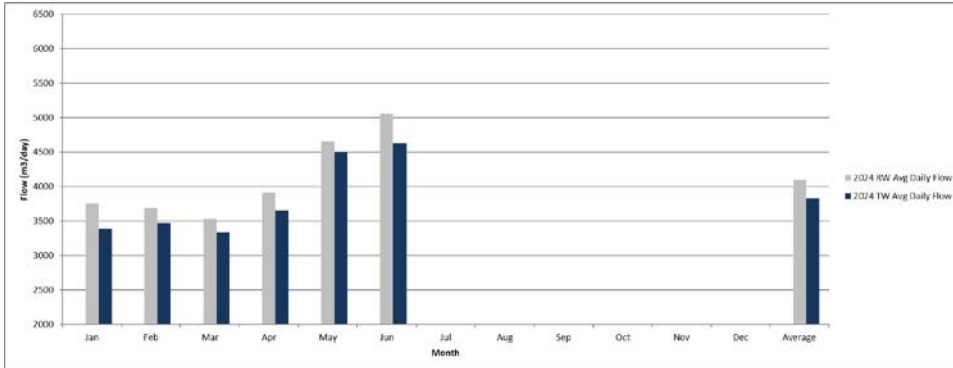
The Tri-County Drinking Water System is currently operating at 93.43% efficiency with the water taken from Lake Erie that is treated and sent to the distribution systems. Chart 1 below shows the raw water takings compared to the treated water distributed to the distribution system so far in 2024.

Chart 1: Average daily water takings compared to treated water distributed to the distribution system

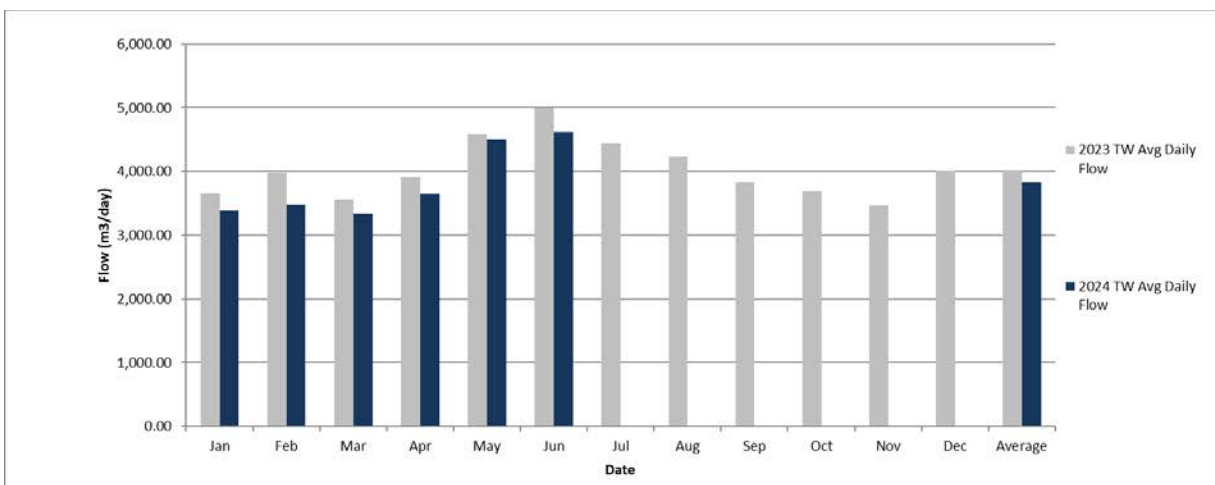
The raw water is treated through membrane filtration and chlorine disinfection. The treated water is distributed to the systems it serves through the high lift pumps. The average daily treated water sent to the distribution in 2024 so far is 3,831.6m³/d. The average treated water flow in the second quarter of 2024 is down 11.5% when compared against the average daily flow in the second quarter of 2023. The Tri-County Drinking Water System is currently at 31.5% of its rated capacity. Chart 2 below depicts the treated water flow for 2024 compared to 2023 average daily flows.

Chart 2: Treated water average daily flow in 2024 compared to 2023

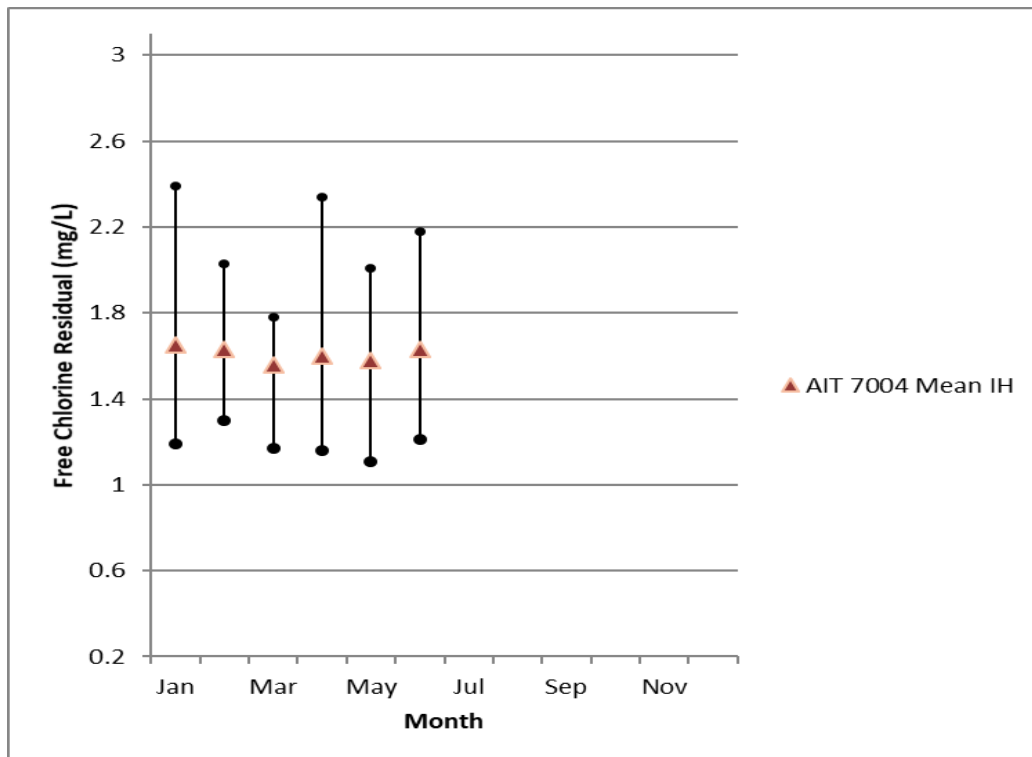
Along with turbidity, chlorine residuals are monitored throughout the treatment process by continuous online free chlorine analyzers. Residuals are maintained in order to provide adequate primary disinfection to meet inactivation of viruses, bacteria and microorganisms. The chlorine also provides adequate residuals in the distribution systems the treatment plant serves (secondary disinfection). Chart 3 below provides the online minimum, maximum and average readings of free chlorine provided to the distribution systems. All results have met regulatory requirements.

Chart 3: Distribution System Free Chlorine Residuals
