# West Elgin Distribution System Operations Report Third Quarter 2020

Submitted by:  
Ontario Clean Water Agency  
Date: November 5, 2020

**Facility Name:** West Elgin Distribution System

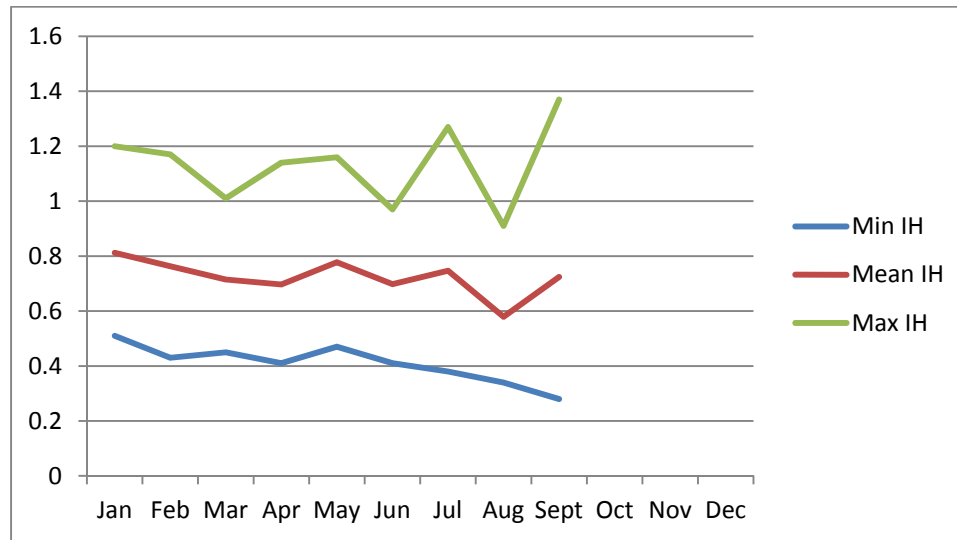
The Rodney Tower continuously monitors the free chlorine residual of the water. The results fluctuate based on fill cycles. During the winter months the results are usually very good, however, once there is warmer weather the chlorine residuals dissipate. In spring of 2018 the Rodney tower installed a re-chlorination facility. Chlorine residuals are taken throughout the distribution system in accordance to O. Reg. 170/03 requirements. The graph below provides the minimum, maximum and average chlorine residuals throughout the distribution system in 2019.
