West Elgin Distribution System Operations Report Fourth Quarter 2020

Submitted by:
Ontario Clean Water Agency
Date: January 8, 2021

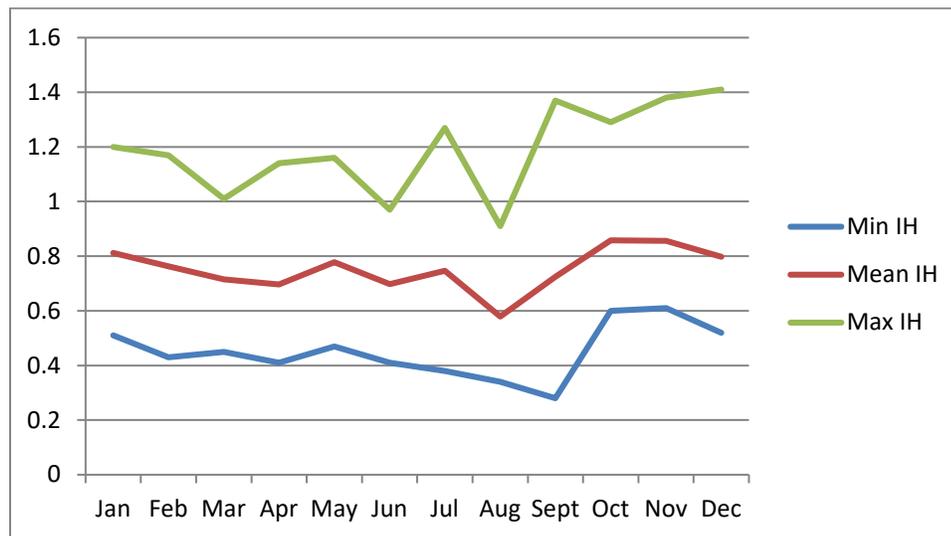
The Rodney Tower continuously monitors the free chlorine residual of the water. The results fluctuate based on fill cycles. During the winter months the results are usually very good, however, once there is warmer weather the chlorine residuals dissipate. In spring of 2018 the Rodney tower installed a re-chlorination facility. Chlorine residuals are taken throughout the distribution system in accordance to O. Reg. 170/03 requirements. The graph below provides the minimum, maximum and average chlorine residuals throughout the distribution system in 2020.
