Tri County Drinking Water System
Operations Report
Fourth Quarter 2021

Ontario Clean Water Agency, Southwest Region
Mark Harris, Sr. Operations Manager, Aylmer Cluster
Date: January 17, 2022

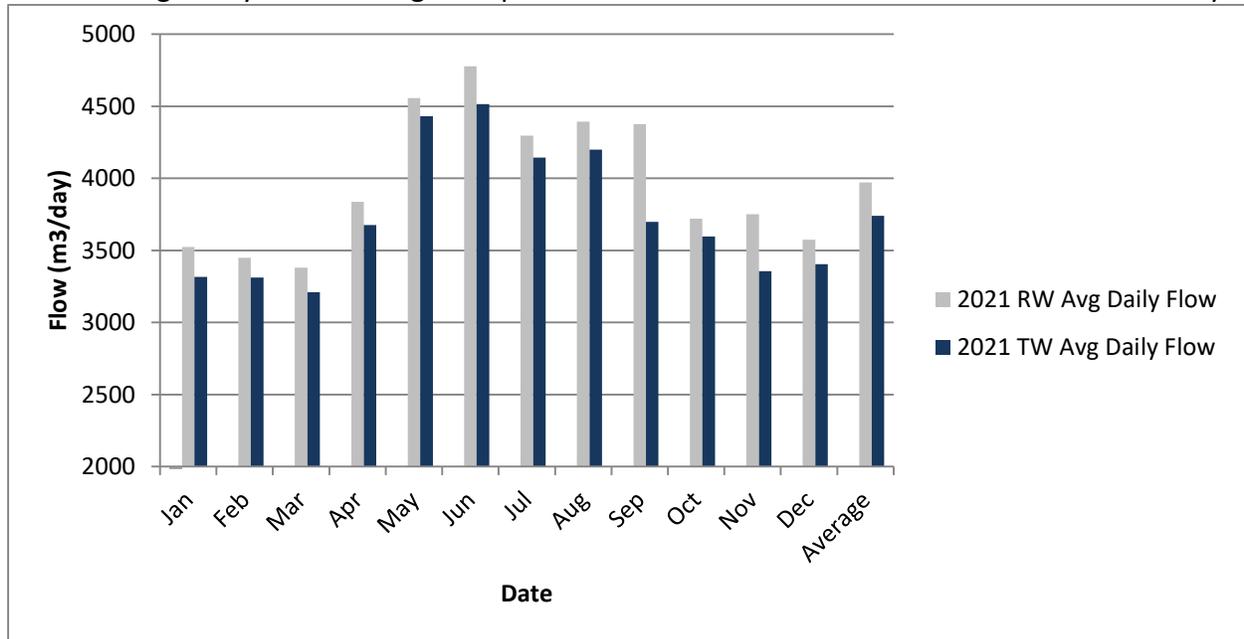
Chart 1: Average daily water takings compared to treated water distributed to the distribution system

The plant is at 94.2% efficiency with the water taken from Lake Erie that is treated and sent to the distribution systems. Chart 1 below shows the raw water takings compared to the treated water distributed to the distribution system in 2021. The treated water average daily flow in September was reduced as the supply to Dutton-Dunwich was temporarily suspended during the yellow water event. The larger difference between raw water volumes and treated water volumes (reduced plant efficiency) is also due to the continuous operation of the water plant during the yellow water event. In November, plant efficiency was also reduced due to maintenance performed on the south storage tank that required the water to be overflowed as part of the disinfection procedure.

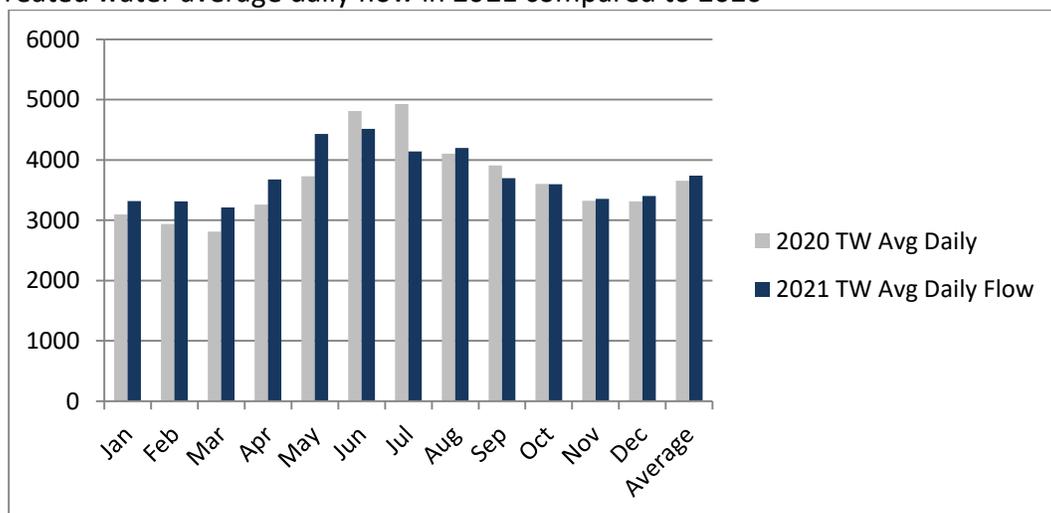
Chart 2: Treated water average daily flow in 2021 compared to 2020

The raw water is treated through membrane filtration and chlorine disinfection. The treated water is distributed to the systems it serves through the high lift pumps. The average daily treated water sent to the distribution in 2021 was 3,741.03m³/d. The average treated water flow in 2021 is up 2.3% when compared against the average daily flow in 2020. The Tri-County Drinking Water System is currently at 30.8% of its rated capacity. Chart 2 below depicts the treated water flow for 2021 compared to 2020 average daily flows.

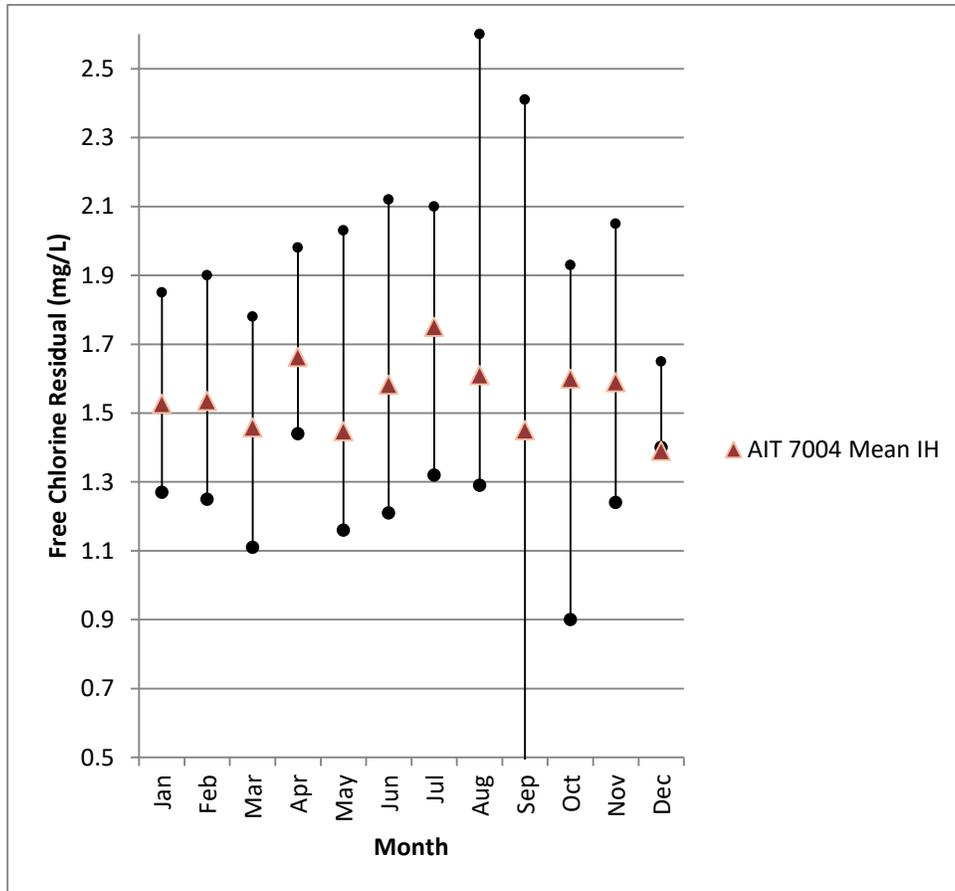
Chart 3: Distribution System Free Chlorine Residuals

Along with turbidity, chlorine residuals are monitored throughout the treatment process by continuous online free chlorine analyzers. Residuals are maintained in order to provide adequate primary disinfection to meet inactivation of viruses, bacteria and microorganisms. The chlorine also provides adequate residuals in the distribution systems the treatment plant serves (secondary disinfection). Chart 3 below provides the online minimum, maximum and average readings of free chlorine provided to the distribution systems. All results have met regulatory requirements. The minimum chlorine reading for September was 0.38 ppm. Lower than normal readings were recorded due to the high chlorine demand caused by the high levels of iron and manganese.
