# Building Condition Assessment & Capital Reserve Fund

## **Service Buildings in West Lorne Ontario 8662 Graham Road, West Lone, Ontario**

Prepared for:  
Ontario Clean Water Agency  
Suite 370 - 450 Sunset Drive  
St. Thomas, ON  
N5R 5V1

Date August 12, 2020  
IRC LB20-024CR-23145

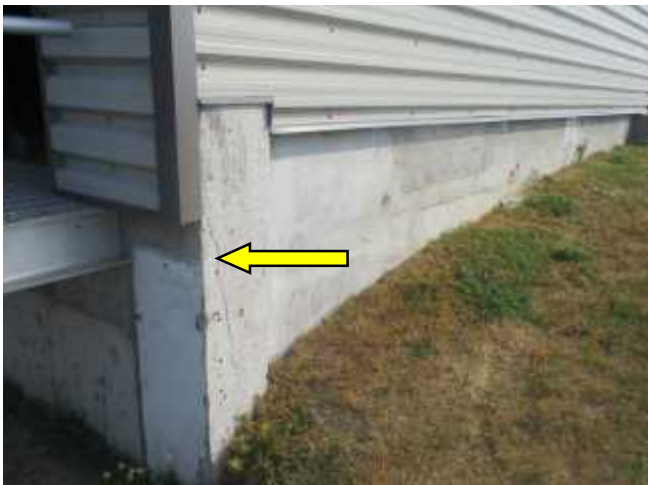
Minor cracking was noted on the foundation wall.

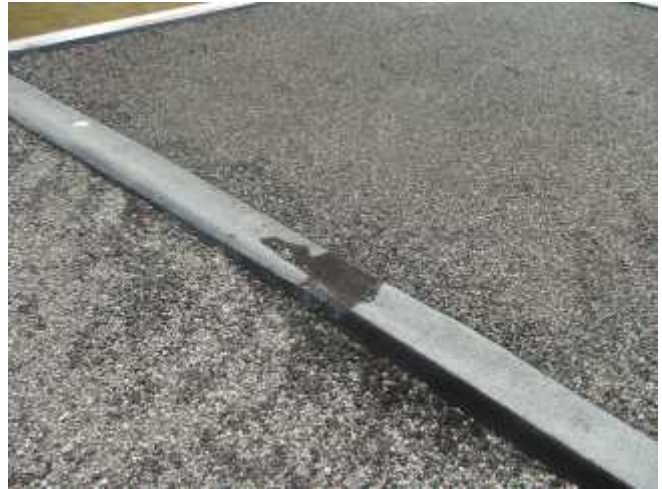
Modified bitumen roof membrane on the control joint of Building A

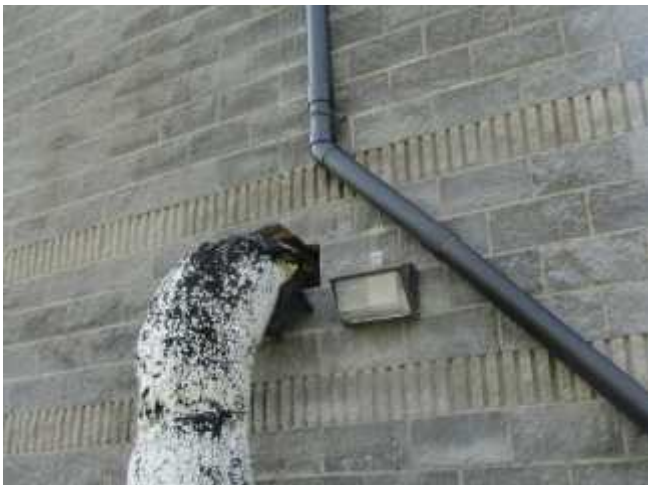
Unsealed pipe-penetration on the north wall of Building B.

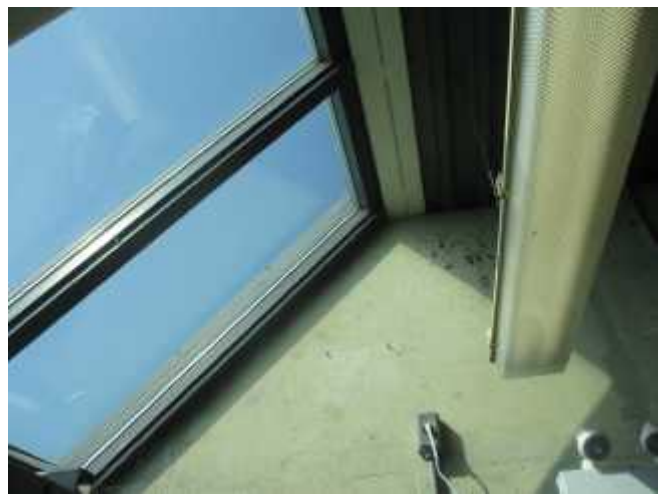
Interior view of the sloped window panels on the south elevation of Building B.

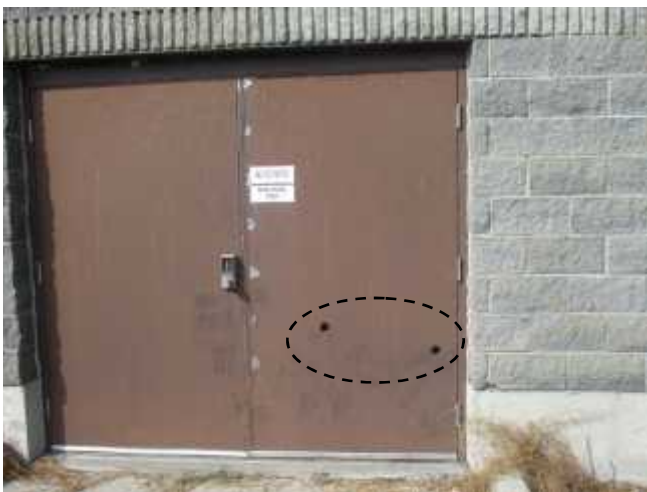
Unsealed holes on the secondary entrance door of Building B.

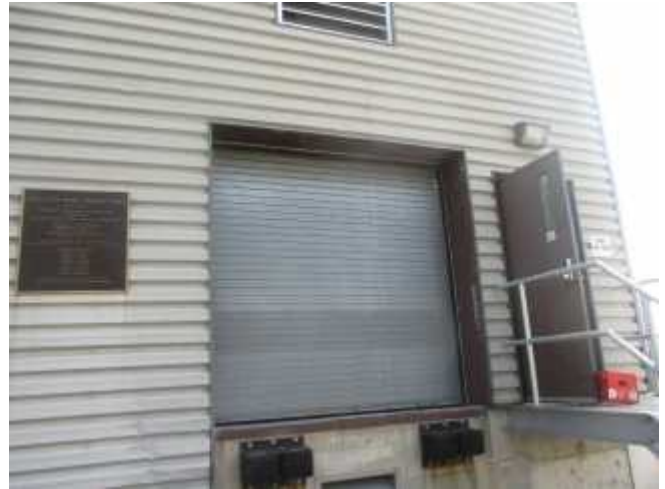
Metal roll-up door serving a loading dock on the west elevation of Building A.

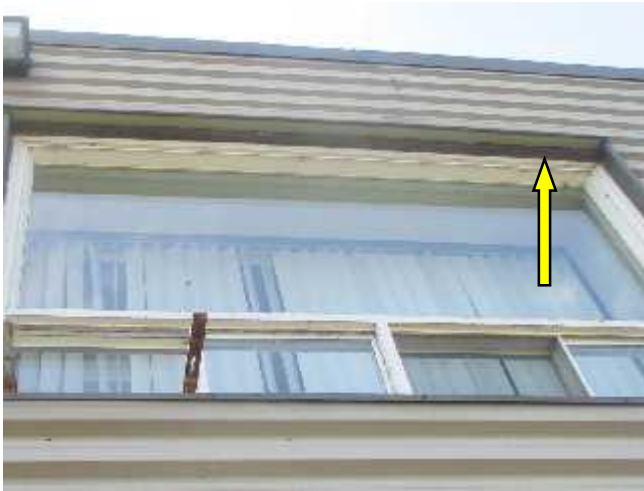
Window perimeter sealants were noted to be in poor condition in Building A.

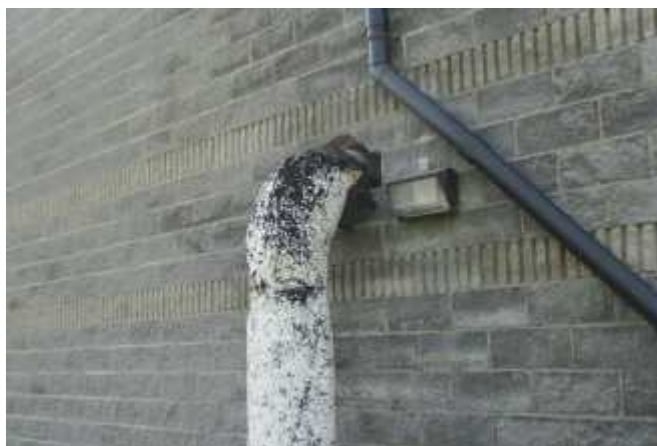
An unsealed pipe penetration on the exterior wall of Building B.

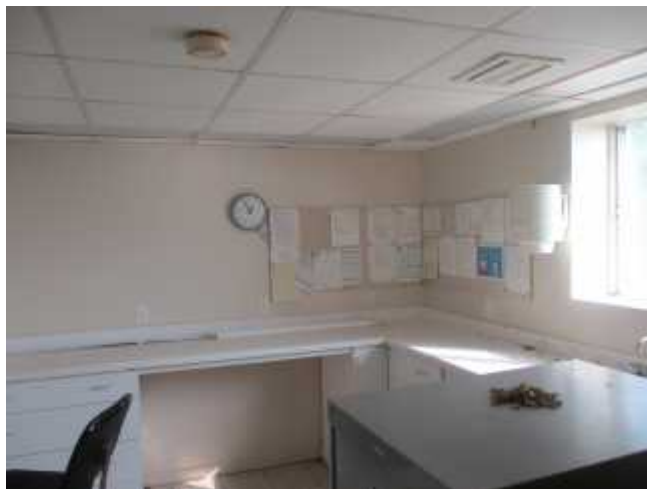
Interior finishes within an office space on the second floor of Building A.

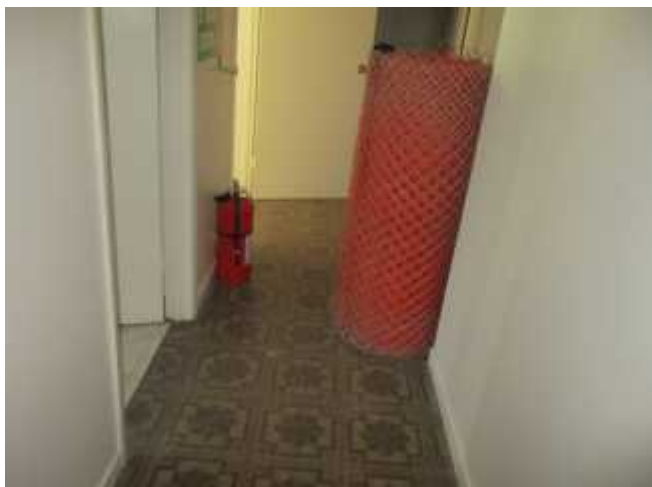
Flooring within the corridor of the second floor of Building A.

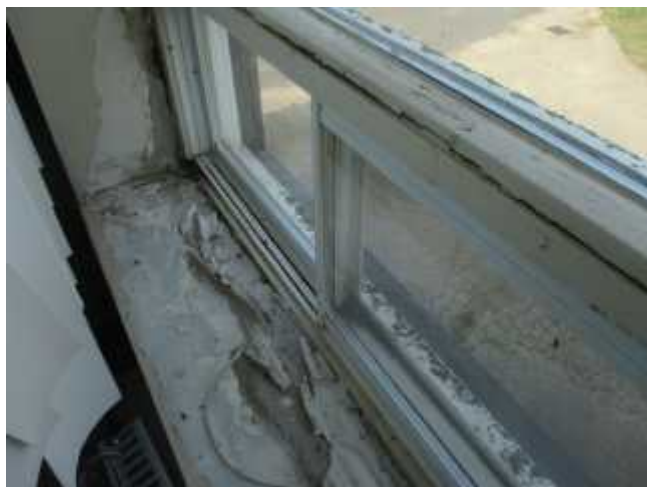
Moisture damage on the window sill on the north portion.

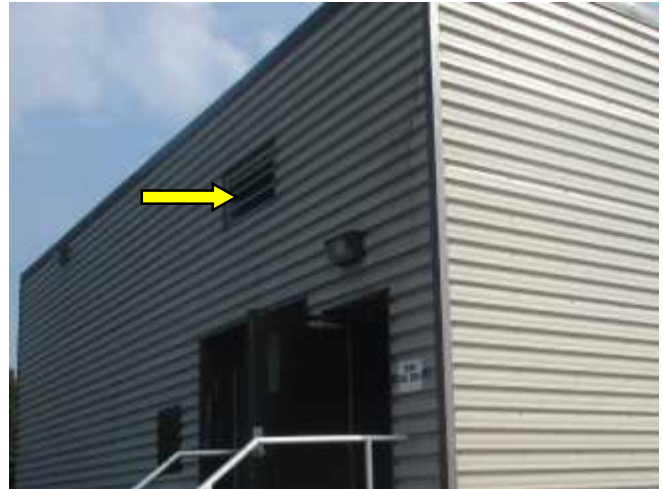
Ventilation louvre on the west elevation of Building A.

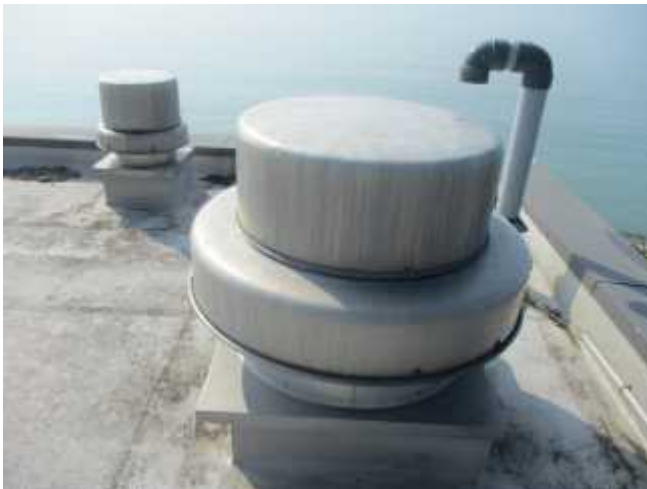
Rooftop hooded ventilation units atop Building B.

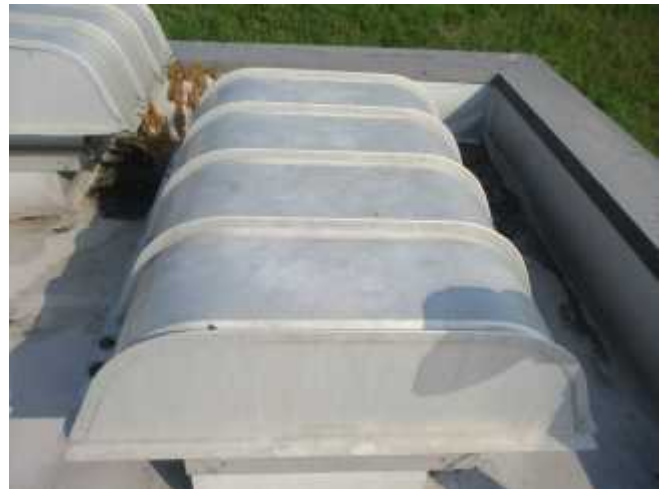
Air intake units on the roof of Building B

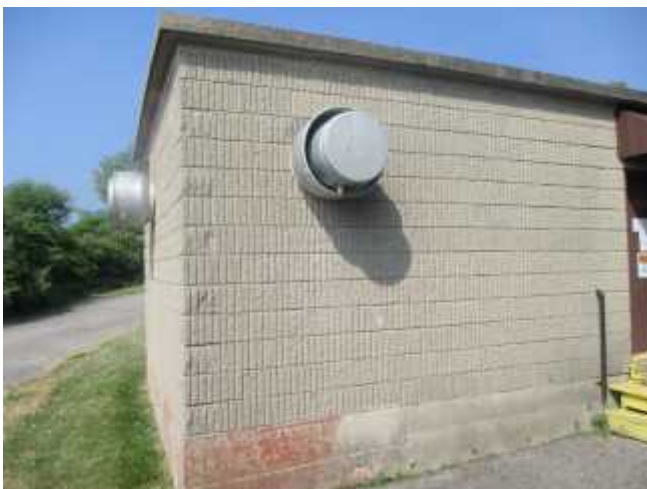
Wall-mounted hooded ventilation units serving Building C.

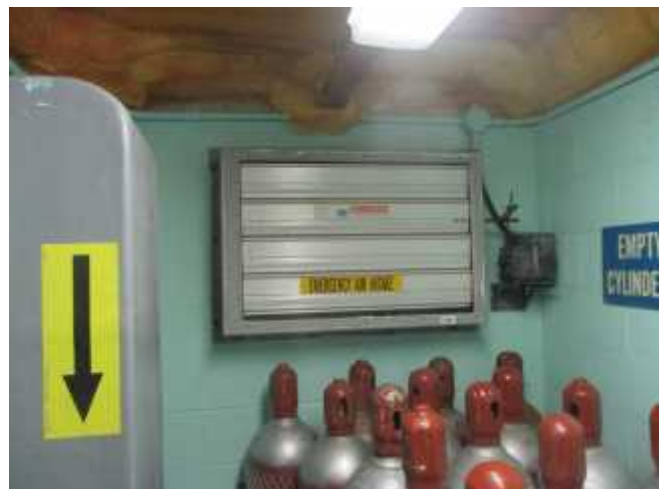
Interior view of emergency air intake unit in Building C.

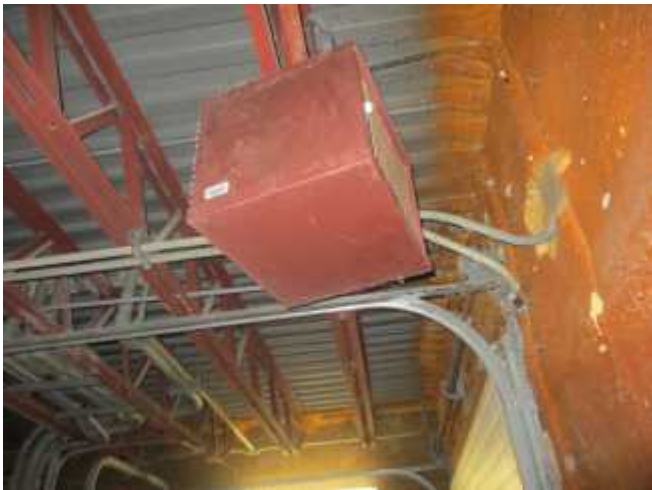
| Photographs | |
|---|---|
| <p align="center">An older space heater in Building A.</p> | <p align="center">Typical heater unit within Building B.</p> |

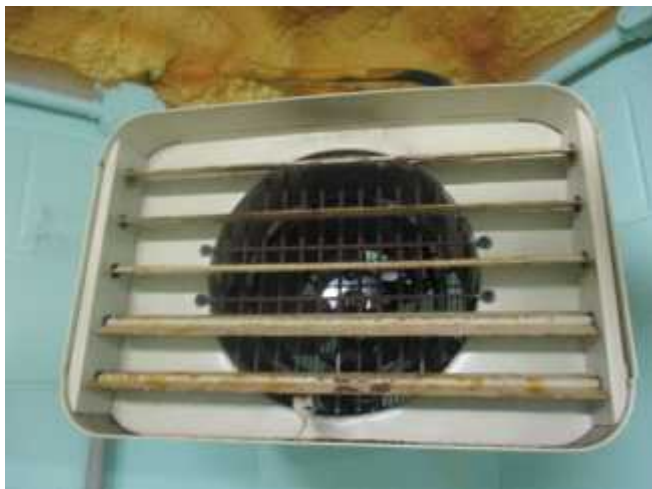
An heater unit in Building C.

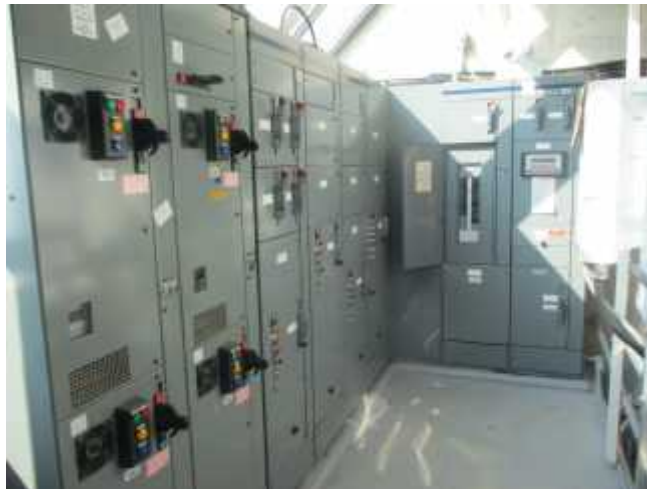
Sub- panels within building B.

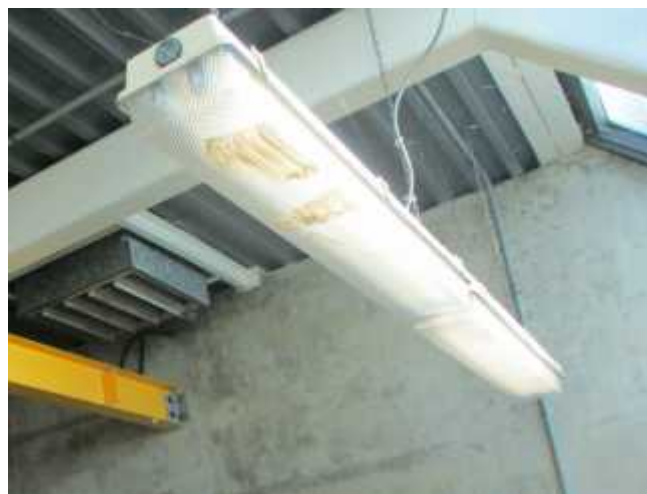
Typical light fixtures and diffusers in Building B.

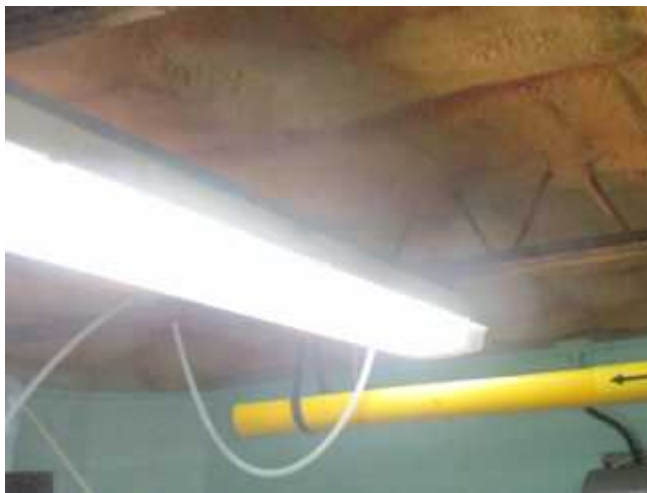
Typical light panels in Building C.

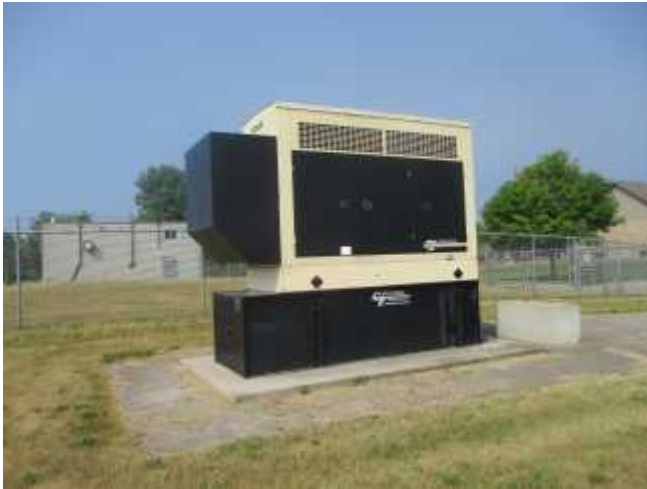
Generator set on the east portion of the site.

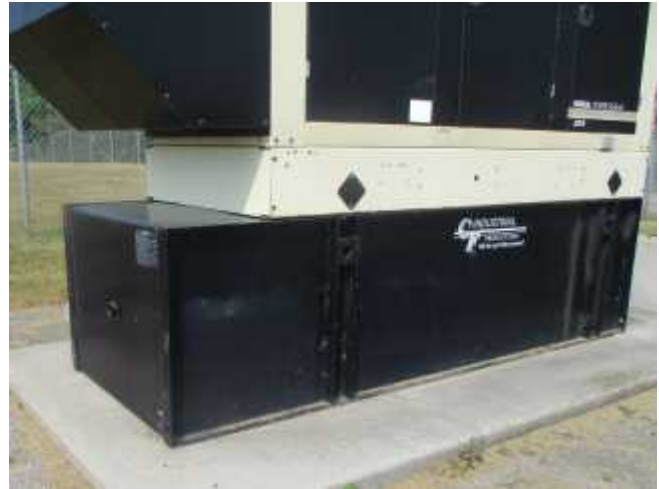
Generator storage tank.

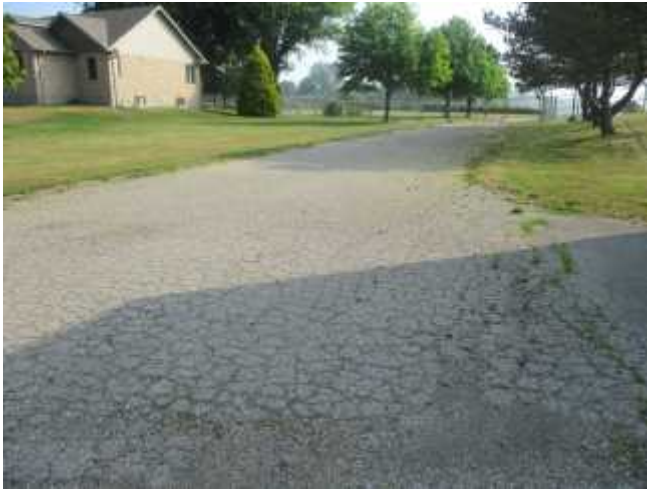
| Observations & Recommendations | | | | | | |
|---|---|---|---|---|--|--|
| <b>Cracked</b> | <input checked="" type="checkbox"/> Severe | <input type="checkbox"/> Moderate | <input type="checkbox"/> Minor | <input type="checkbox"/> None | | |

Asphalt pavement deterioration manifested in the form of severe alligator cracking on the north portion of the site.

| Summary Budgetary Costs | | | | |
|---|---|---|---|---|
| \$165,000 | 27500 sq. ft. | 2 - 5 Years | Recommended | An allowance for repaving of the site asphalt. |

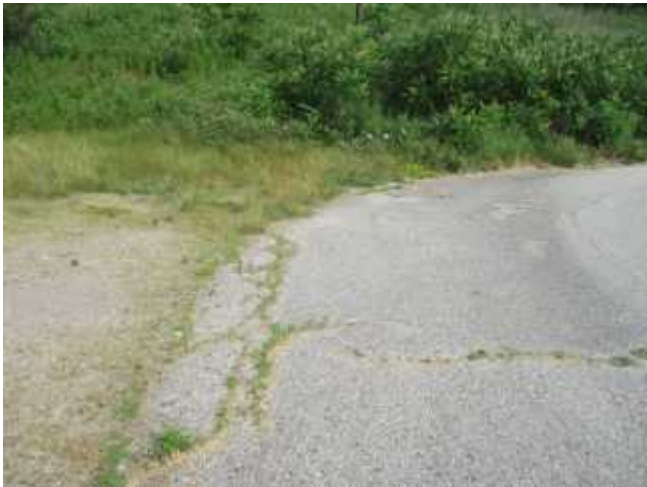
Cracking and growth within the cracks of the asphalt pavement.

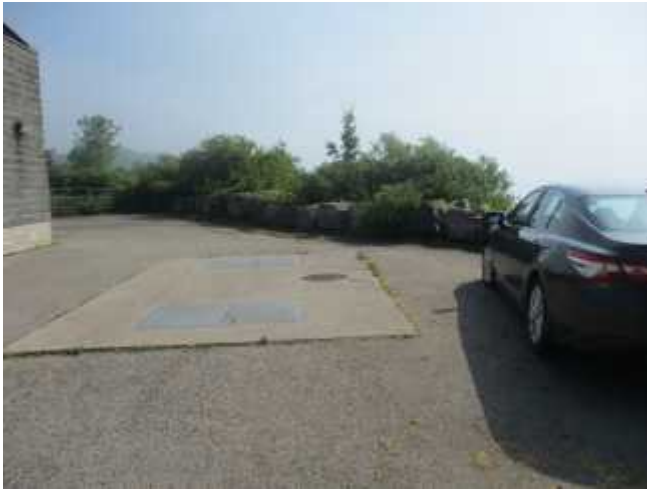
Concrete pad adjacent to the south elevation of Building B, likely atop an underground storage tank was noted in good condition.

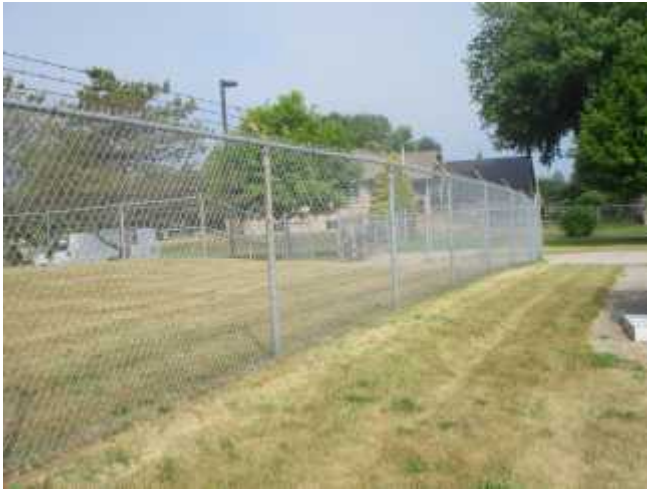
General view of the fencing south of Building A.

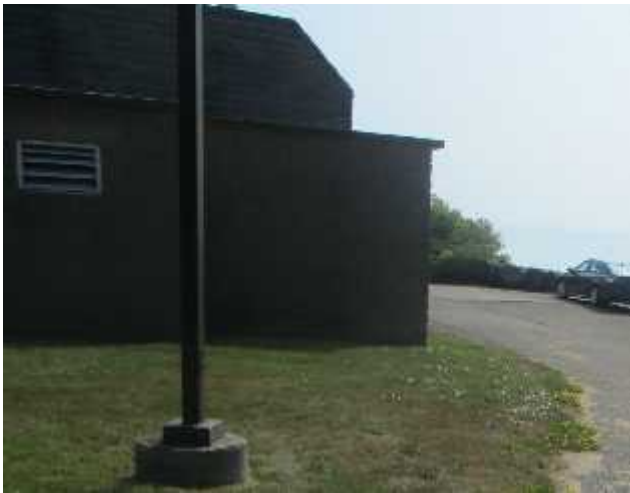
| Photographs | |
|---|---|
| <p>Exterior light posts on the central portion of the site.</p> | <p>Concrete base of the light posts were noted in good condition.</p> |

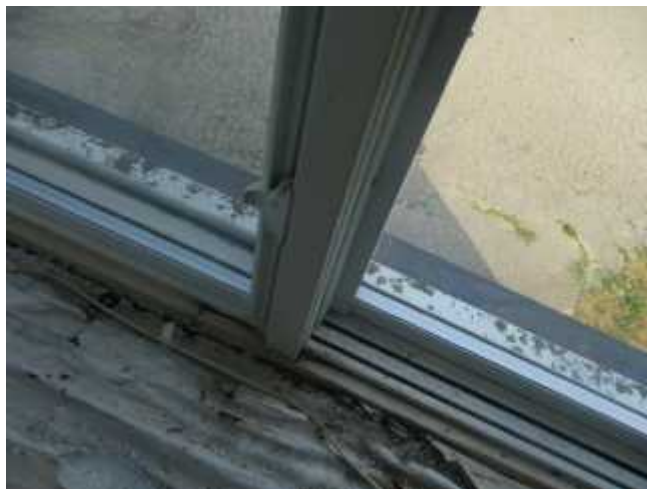
Mould growth is evident on the exterior face of window frame.
